Victory Property Inspections

General Information

BUILDING ADDRESS: 7777 Superman Hwy
CITY: Atlantis
STATE: Georgia
ZIP CODE: 11223
INSPECTION DESCRIPTION: General Home Inspection
SQUARE FOOTAGE: 2245

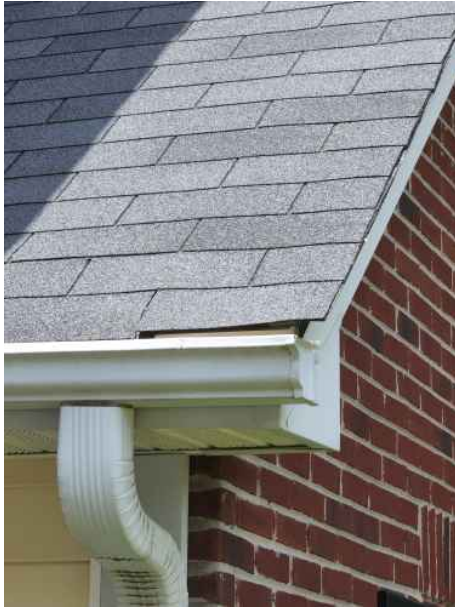
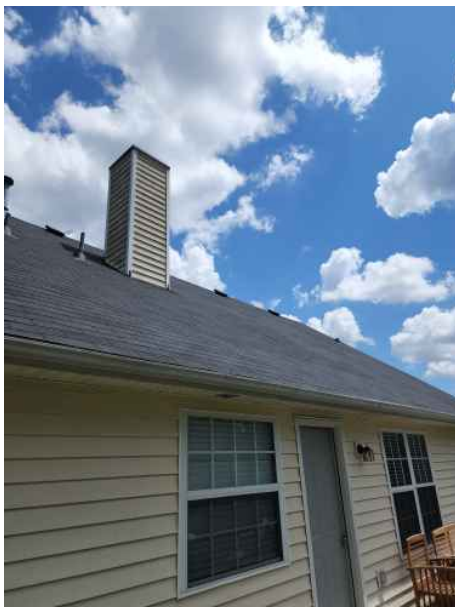
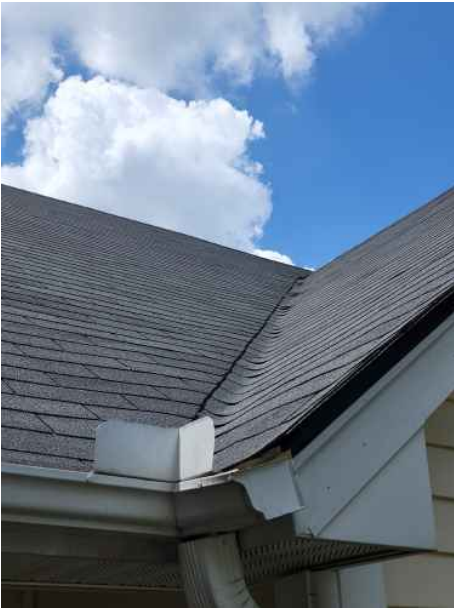
3 tab roof is under one year old, has multiple nail pops due to installation nails not being long enough or possibly contraction and expansion due to climate.

Recommend further evaluation by a qualified contractor.

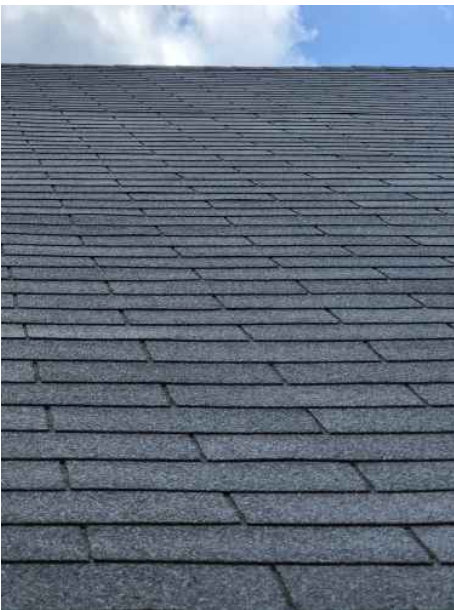
3 tab asphalt shingles in new and great condition

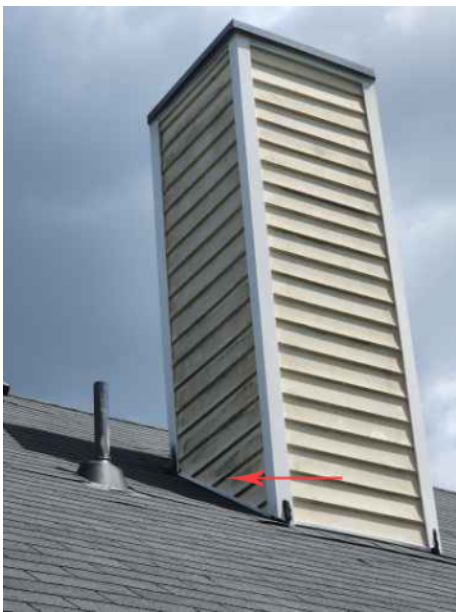
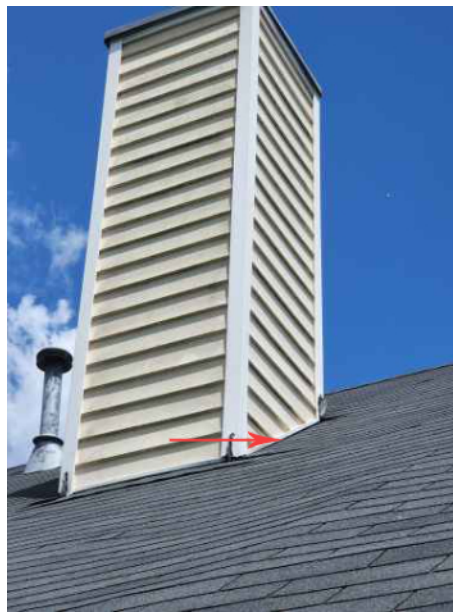
Chimney counter flashing is missing. This flashing is needed to create a seal to protect the roof and Chimney from water damage.

Recommend repair/evaluation by a qualified roofing or Chimney contractor.

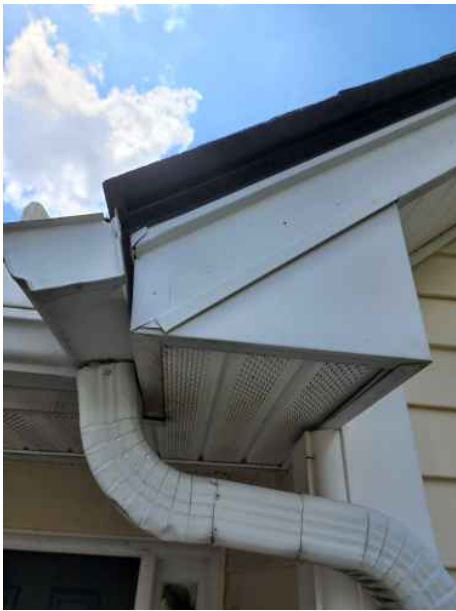
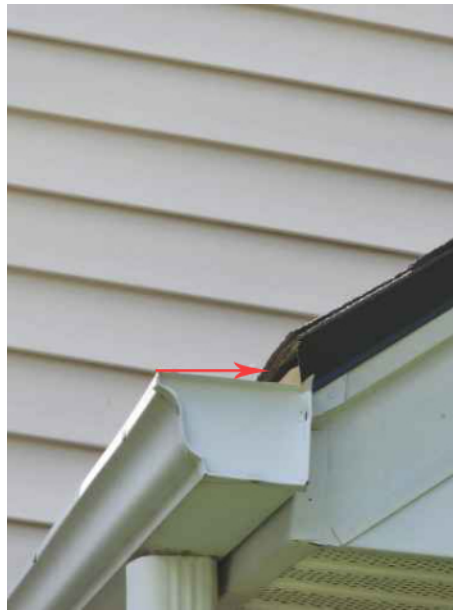
Drip edge located above the front room window is causing a gap between the shingles and the framing. This could eventually allow water to get in and also pest/insects, and should be repaired.

Recommend further evaluation by a qualified roofing contractor.

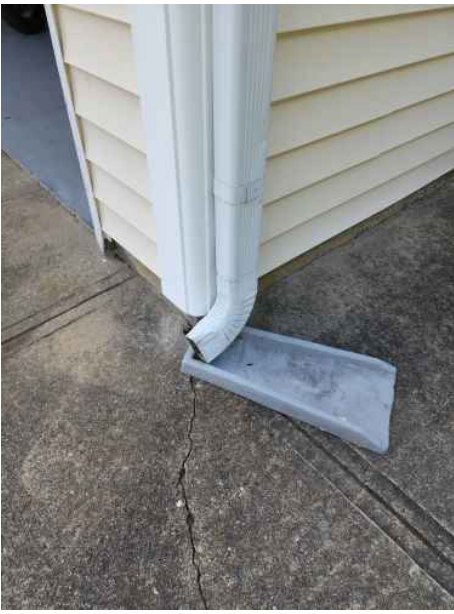
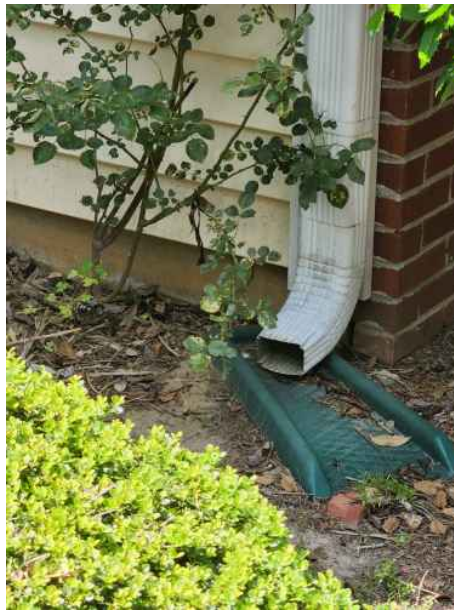
Gutter spout on rear of the home right side (from facing home) is not attached to the Gutter causing improper drainage.

Gutter spout on the left side of home is damaged possibly by a lawn mower. Replacement of lower spout will be required before extension can be added.

All spouts should be repaired by homeowner or qualified contractor

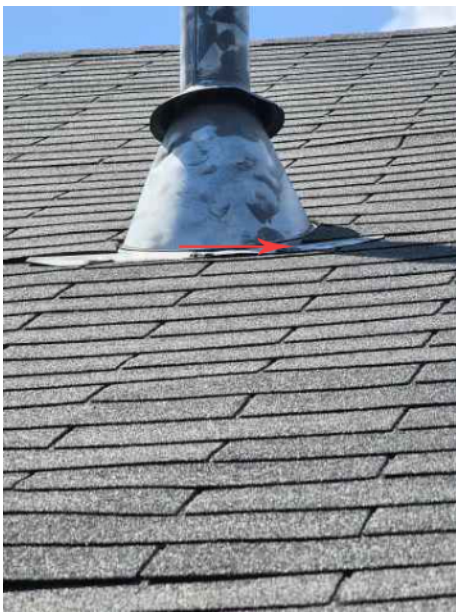
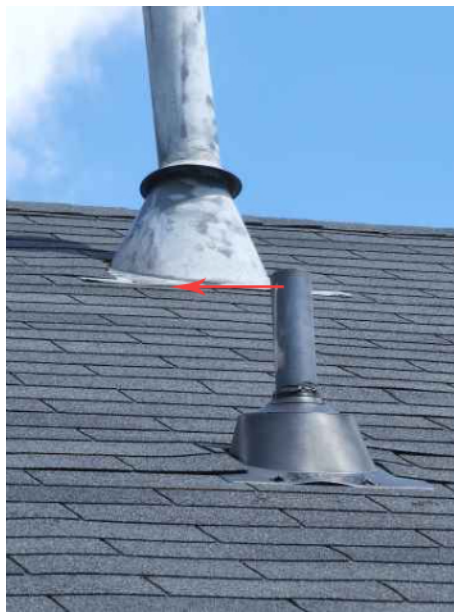
Combustion vent flashing on roof is old and can be replaced with a newer boot.

Condition is typical for an item of this age, and would've been great to have been replaced at the same time the new roof was installed.

Although sealing properly this flashing was most likely installed in 1999 when the home was built, making them 23 years old.

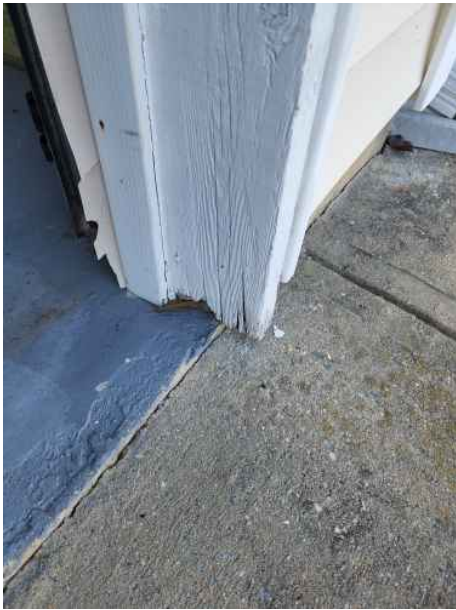
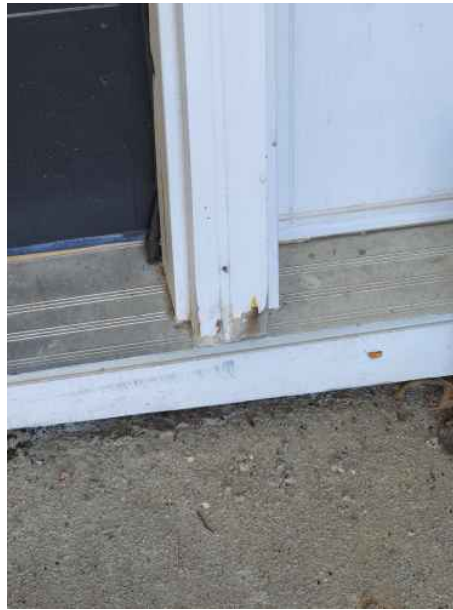
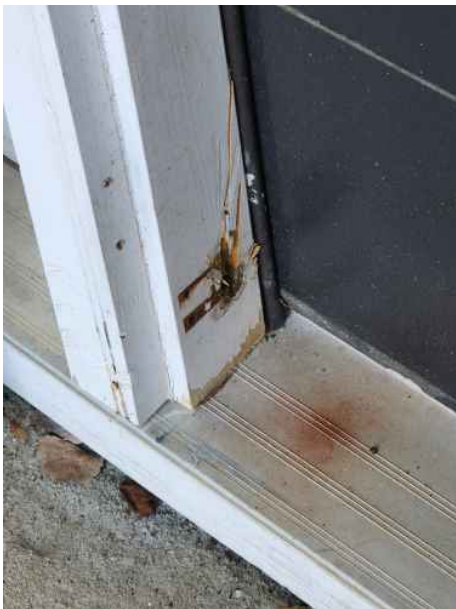
Condition is typical for an item of this age and the deterioration of the wood trim can be seen in a few photos below. (Front door, and garage door trim pictured below)

Note If planning on painting the exterior of the home also plan on having new trim installed at the same time. Trim can be repaired in most instances and due to the age of this trim it would be best to have it replaced.

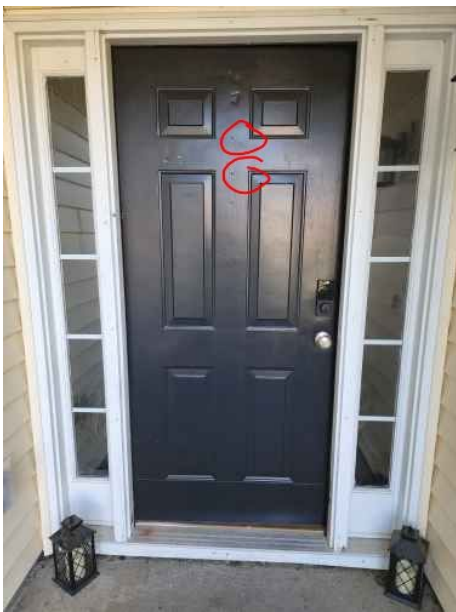
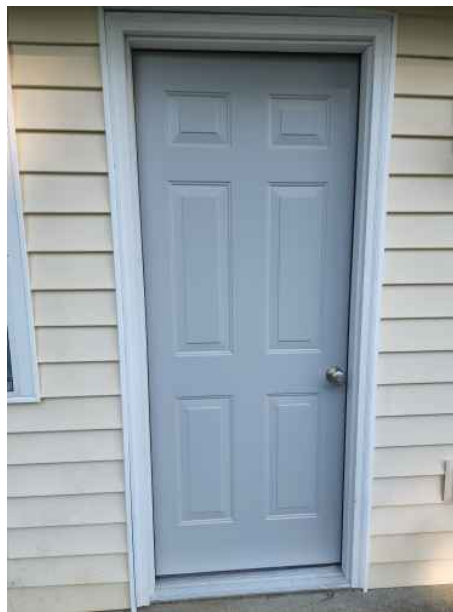
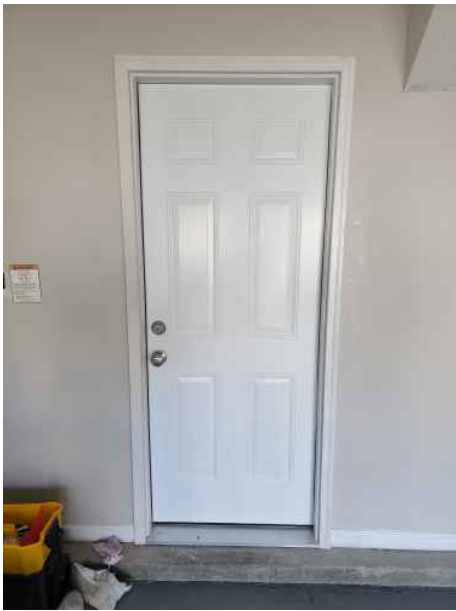
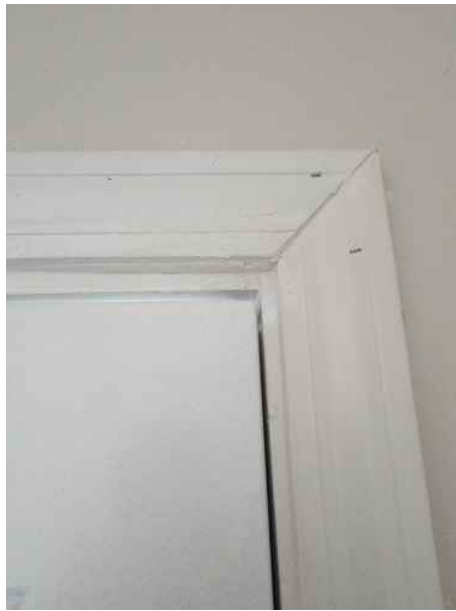
Two wholes are drilled into the main exterior entrance allowing air loss, insects, and guest to peer into the home. Aside from the pest intrusion this is a safety Hazzard allowing a view into the home through the wholes. Recommend repair / replacement by a homeowner or handyman. Also on the same door there is some dings or dents but they are just cosmetic.

On the inside of the door leading from the garage in the upper right corner repairs have been made. Recommend inquiring with the current homeowner as to why. This is not necessarily cause for alarm, but something any homeowner should be aware of.

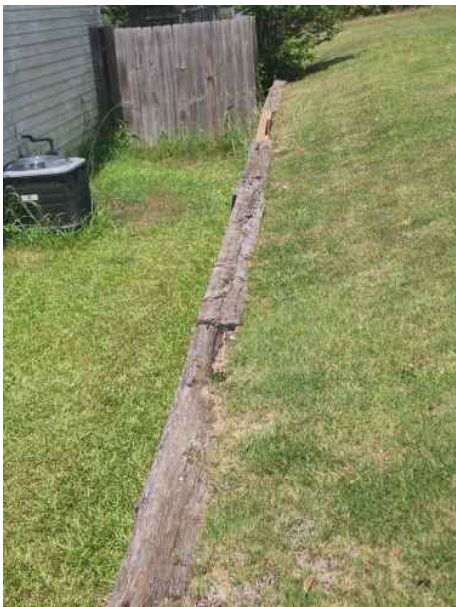
Retaining wall is old and damaged and should be repaired/replaced by a qualified contractor.

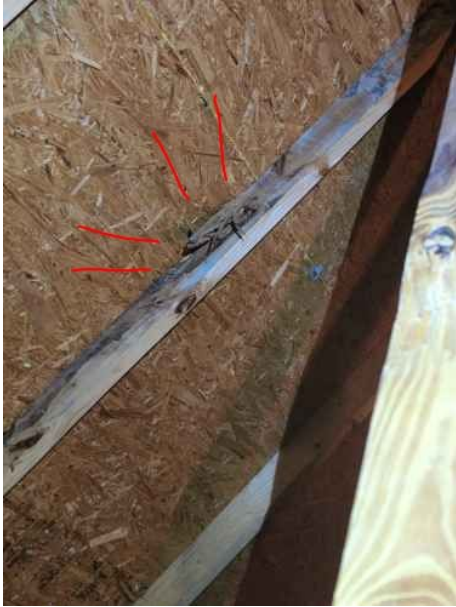
Damage was observed on one of the roof trusses, recommended further evaluation and or repair by a qualified contractor.

Also noted was a one piece of frame work that is not attached to anything. Appears this was done when the home was built and is not something to be alarmed about, just something for the owner to know.

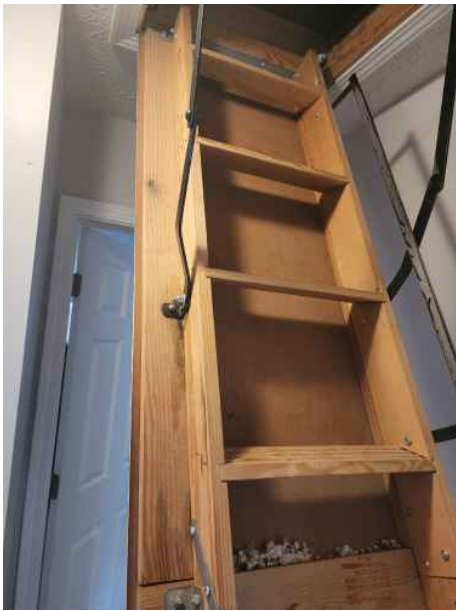
Attic ladder access is missing insulation.

Recommend repair/installation by a qualified contractor to prevent drafting.

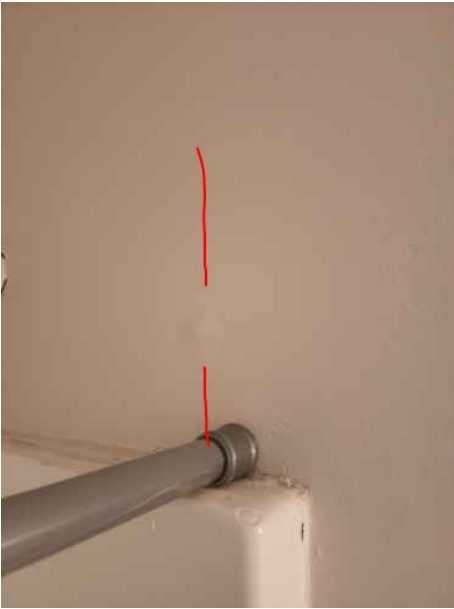
Previous areas of repair were observed, at the discretion of the owner I recommend to have these spots sanded, primed, and painted. (Cosmetic issue)

Right corner above tub surround is missing caulking and should be replaced by the owner or a qualified contractor.

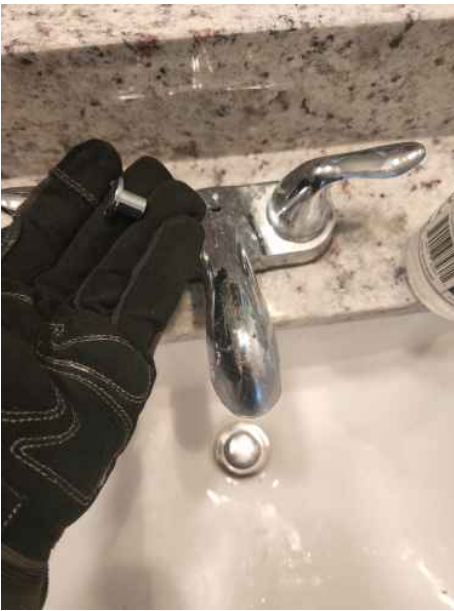
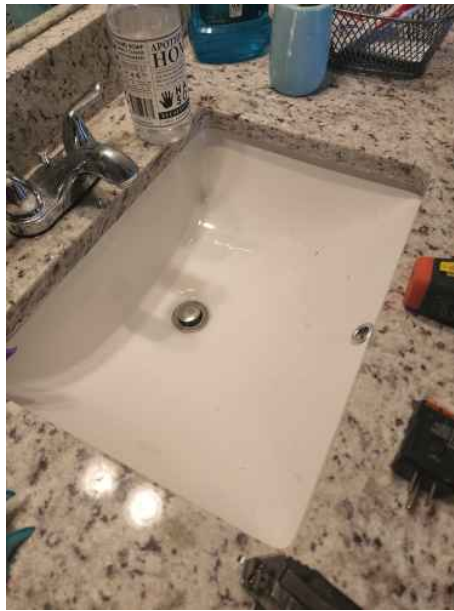
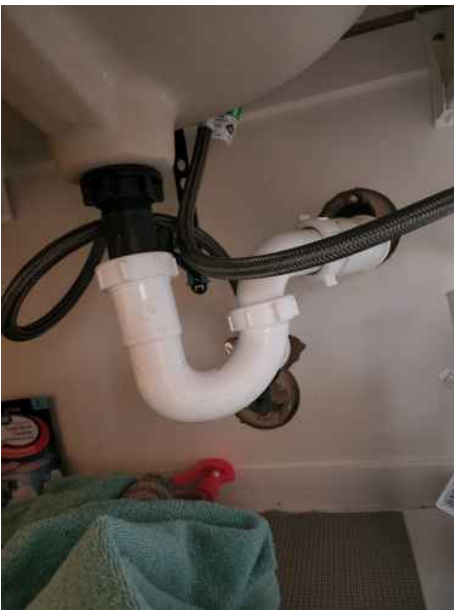
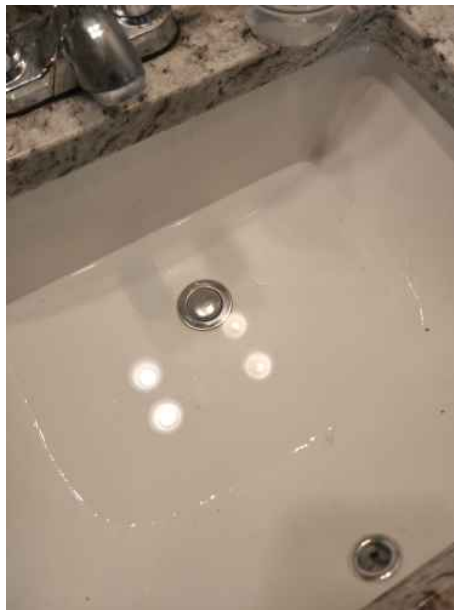
Right side of the counter top is missing sealant or caulking. This caulking will prevent water from the sink getting in between the counter and wall causing damage/rot/mold ect.

Handle on sink stopper in guest bathroom is broken and just sitting on top of the rod. Stopper does function as needed seen in the photos.

Recommend repair / replacement by a homeowner or handyman.

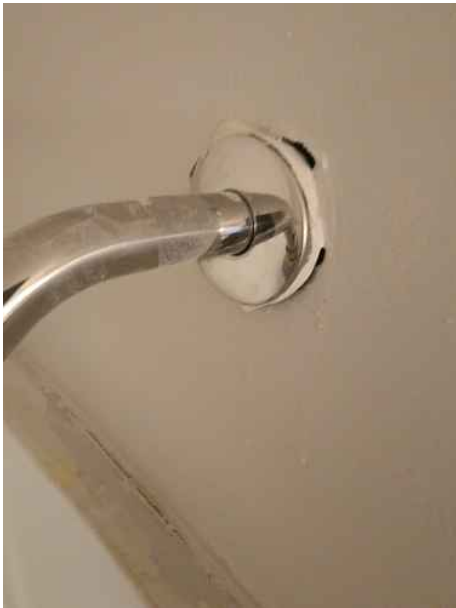
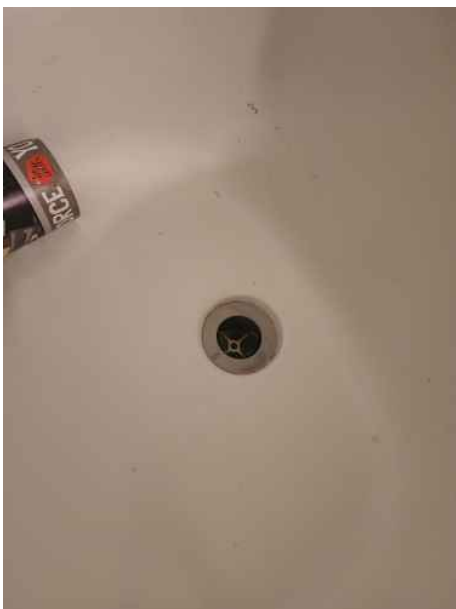
Sealant is missing around the shower head to the wall.

Tub stopper/boot plug is missing.

The shower has a small Drip or leak once the handle is closed and needs to be closed just right for the water to stop flowing.

Recommend repair / replacement by a homeowner or handyman.

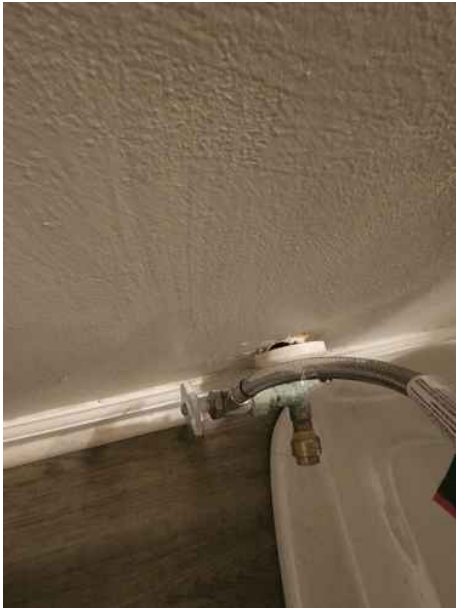
Water line cap to toilet should be affixed to the wall and sealed to prevent any water intrusion.

Recommend repair / replacement by a homeowner or handyman.

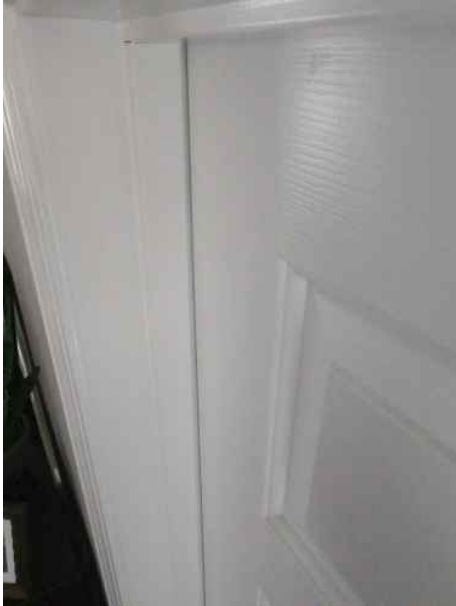
Door does not shut completely when closed and an extra push or pull is needed.

Recommend repair / replacement by a homeowner or handyman.

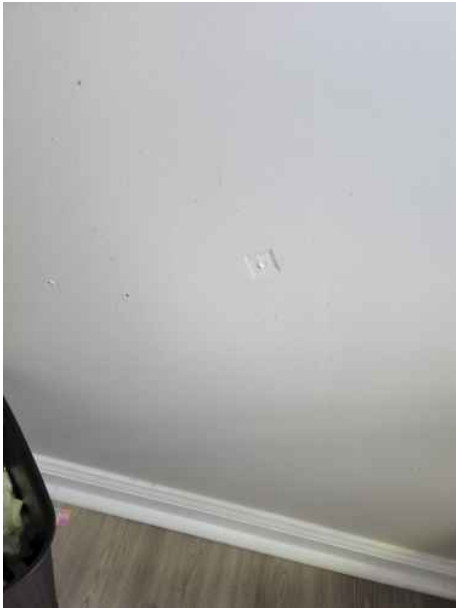
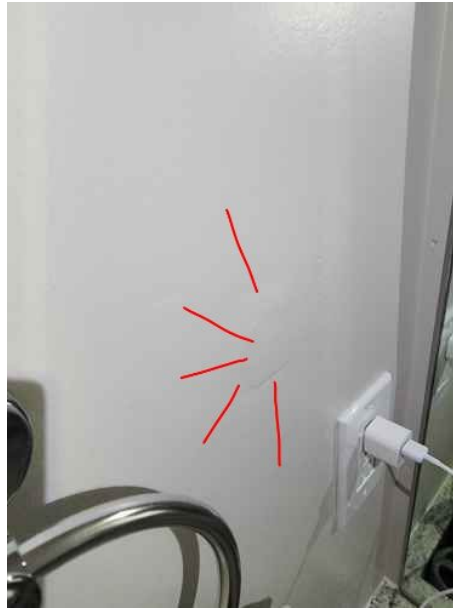
A few small areas of previously repaired areas were observed. Before painting these should be smoothed/sanded.

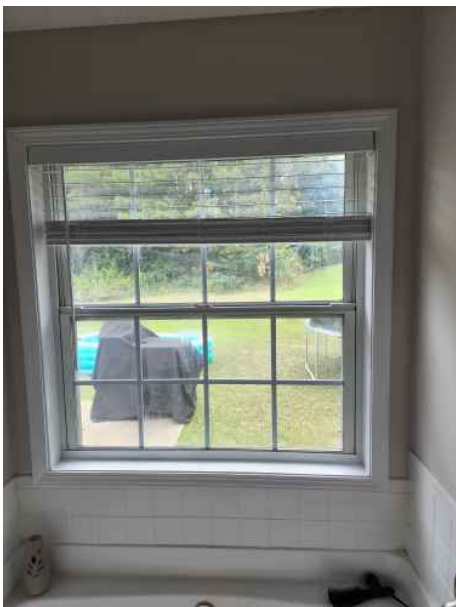
note All windows in and around home have damaged seals and should be replaced or repaired at the home owners discretion.

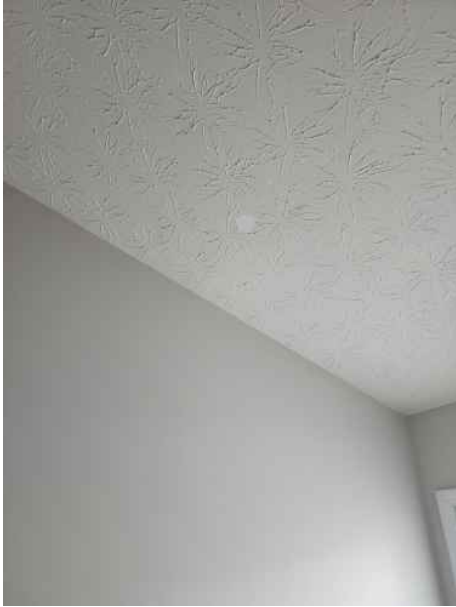
Poor job at doing a ceiling repair from most likely water damage can be seen. No current water leak was observed at the time of inspection.

Ceiling paint has chipped, or fallen off seen in photo.

Recommend repair / replacement by a homeowner or handyman.

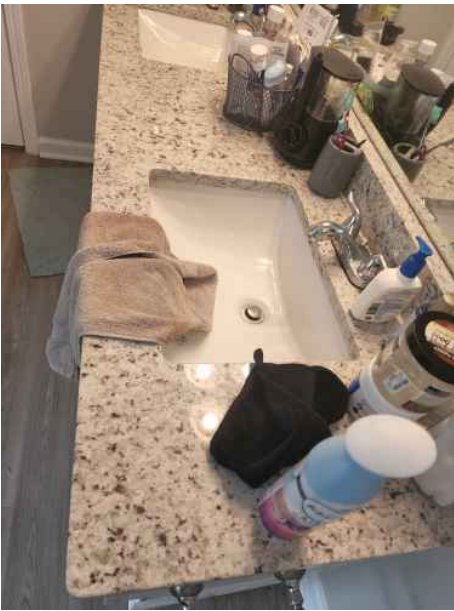
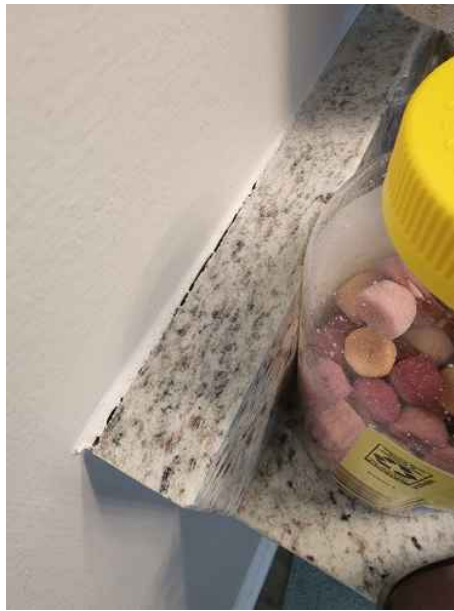
Sealant along the left side of the sink is missing.

Recommend repair / replacement by a homeowner or handyman.

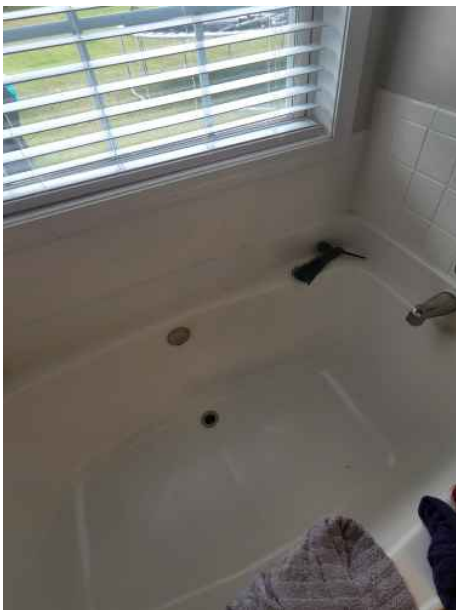
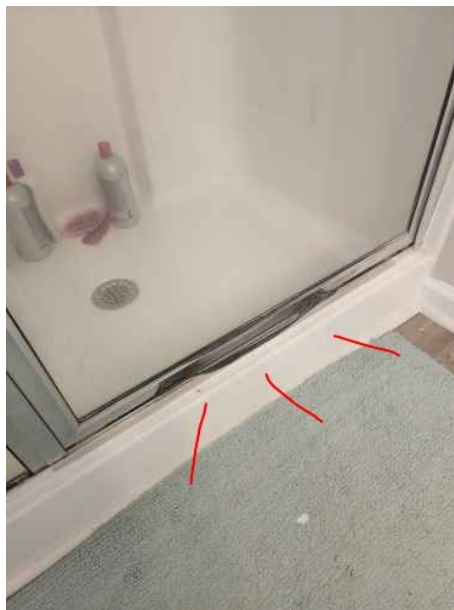
Tub stopper/boot plug is missing.

Damage to the shower door seal was observed.

Recommend repair / replacement by a homeowner or handyman.

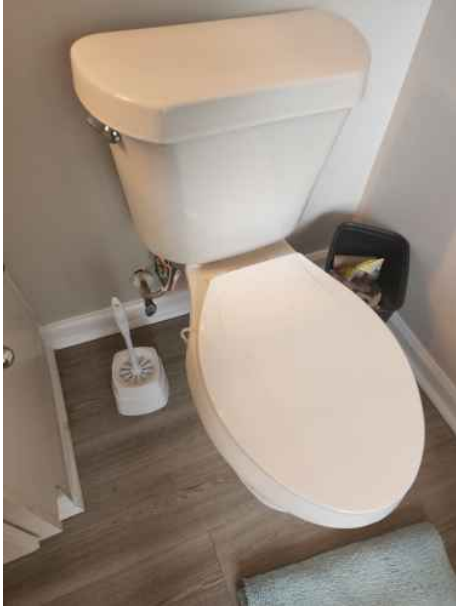
Toilet seat is loose and was tightened.

There is a hole in the wall above the toilet water line cap seen in photo.

Recommend repair / replacement by a homeowner or handyman.

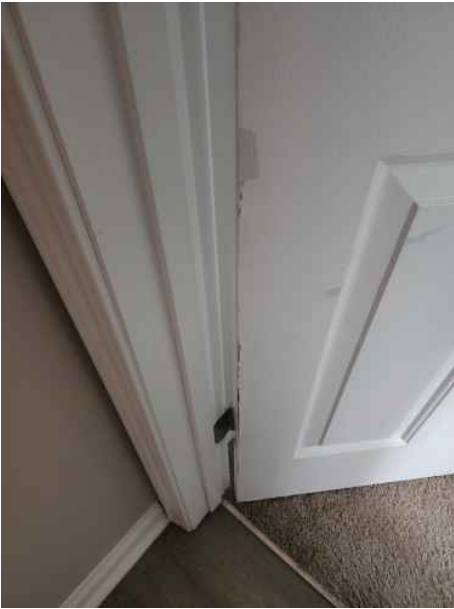
Master bedroom door needs to be adjusted and is rubbing the door jam when closed. The damaged paint seen in photo is a result of this.

Recommend repair / replacement by a homeowner or handyman.

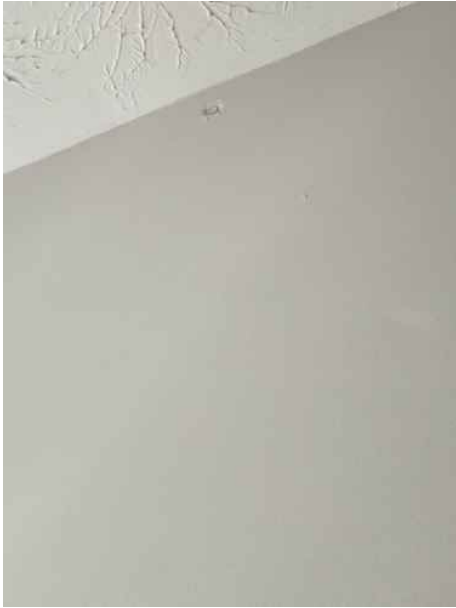
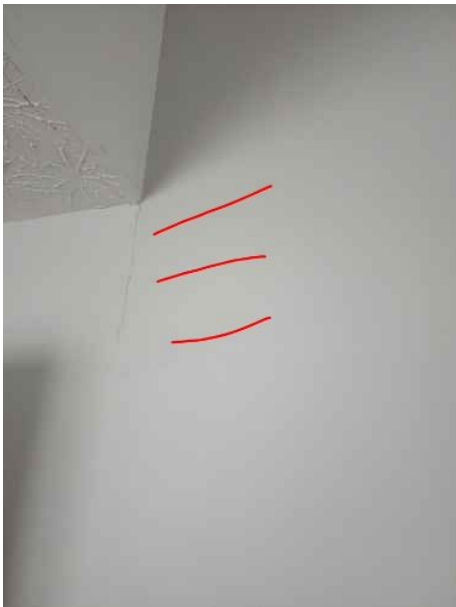
Cracks were observed on the walls in the master bedroom, these could be caused by the house settling and are usually not cause for alarm. In this case due to the size and locations of the cracks the inspector recommends further evaluation to be completed by a qualified building specialist or structural engineer.

In the first photo a nail has been inserted into the wall and painted over, it's purpose is unknown. Recommend repair / replacement by a homeowner or handyman.

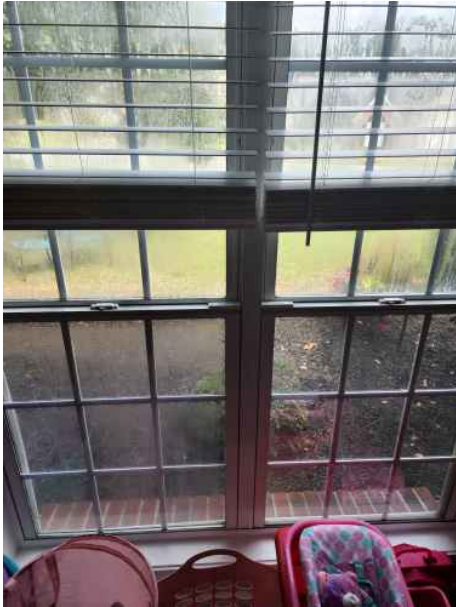
Both window locks are broken in bedroom 2 located next to the master bedroom.

note All windows in and around home have damaged seals and should be replaced or repaired at the home owners discretion

Recommend repair / replacement by a homeowner or handyman.

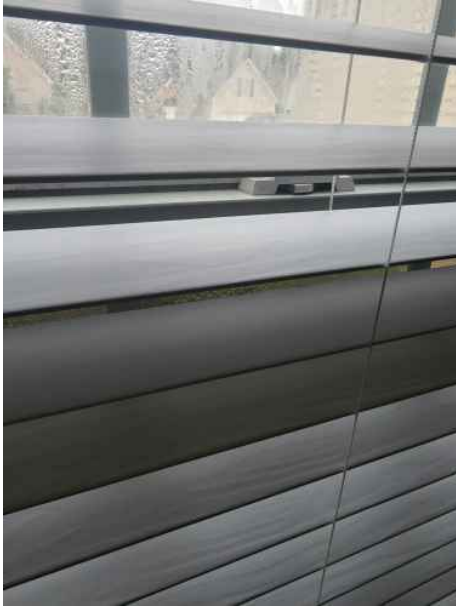
Window lock on the left side is broken and needs to be replaced.

One damaged window seal can be seen in the second photo, this is likely the condition of all windows located around the home. Please see note below

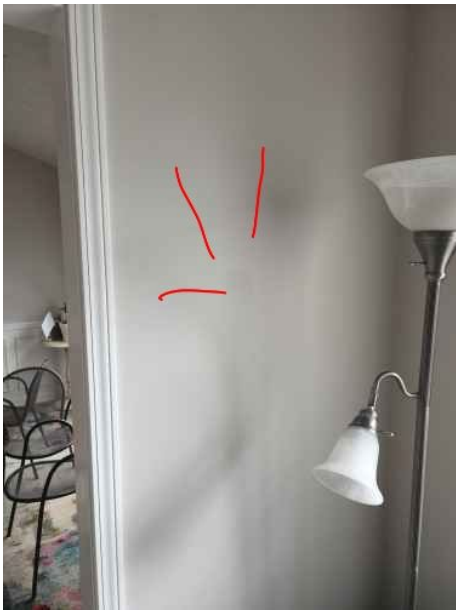
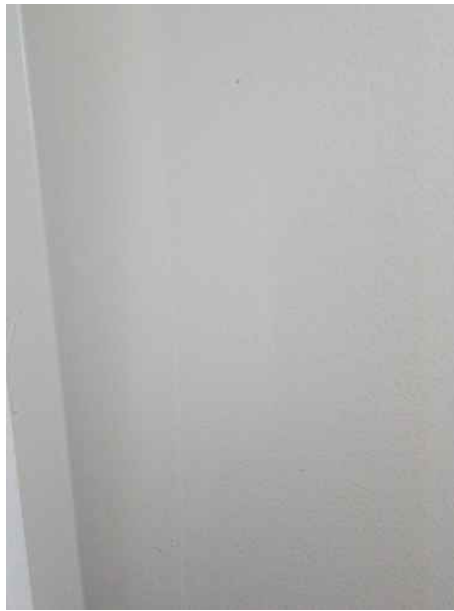
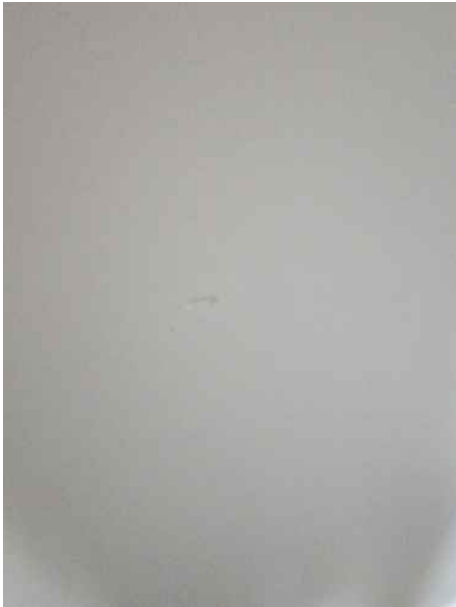
Various areas of previous repairs were observed, recommended to have the walls smoothed/sanded before painting.

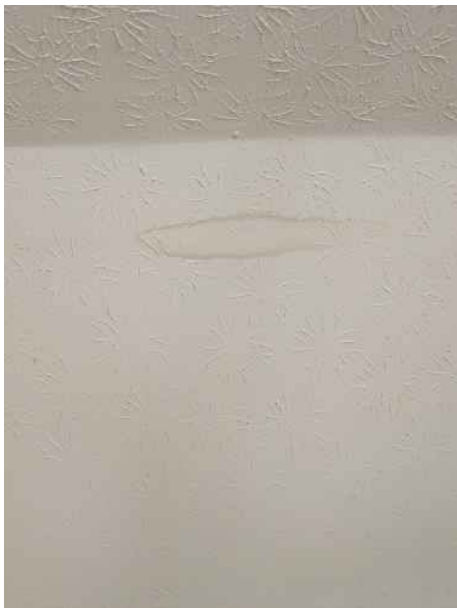
Previous water stains were observed on the ceiling in the living room, no water leaks were present at the time of inspection.

Recommend repair / replacement by a homeowner or handyman.

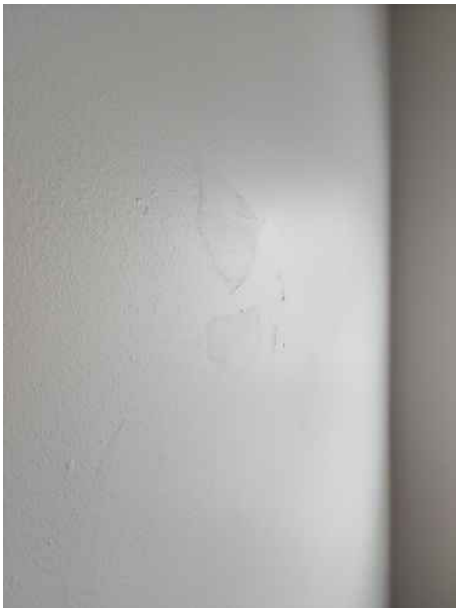
Various areas of repairs were observed, recommend to have walls smoothed/sanded before painting.

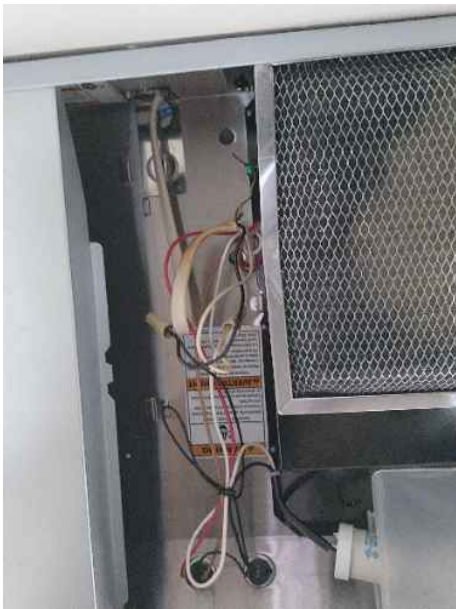
Oven exhaust hood did not turn on under normal operating conditions during the inspection.

Recommend repair / replacement by a homeowner or handyman.

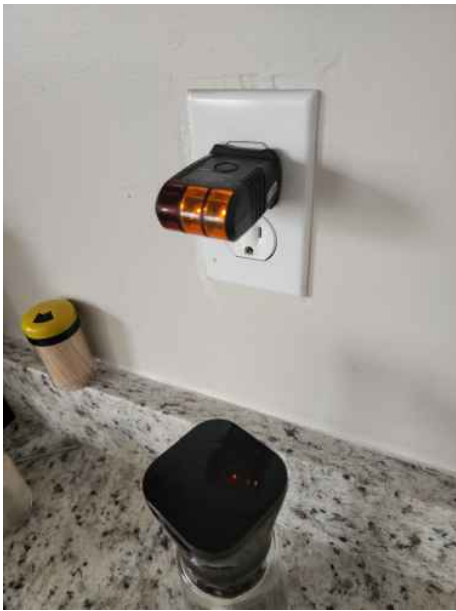
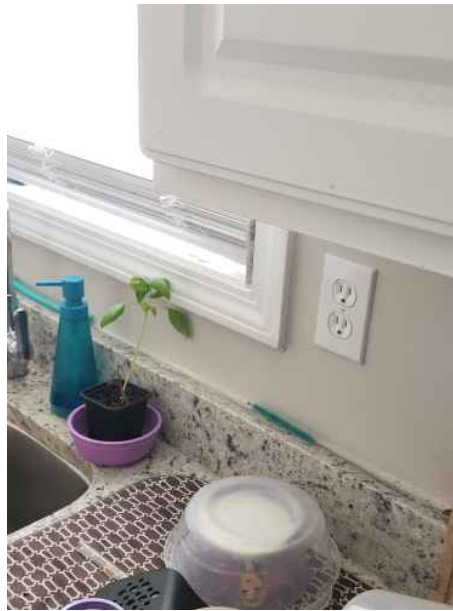
Although wired properly, outlets within 6 feet of a water source need to be GFCI outlets for safety. There are 6 outlets located around the sink that are in question.

Recommend repair / replacement by a homeowner or handyman.

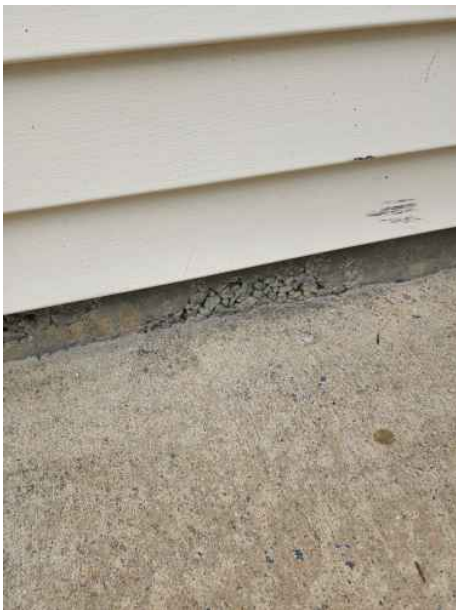
Foundation deterioration can be observed around all sides of the home.

Recommend further evaluation by a qualified foundation specialist or structural engineer.

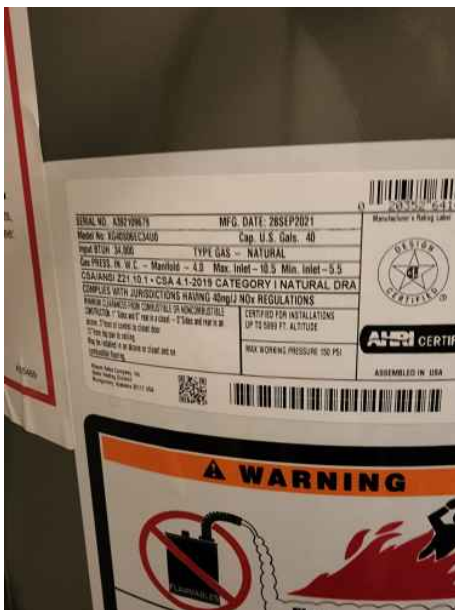
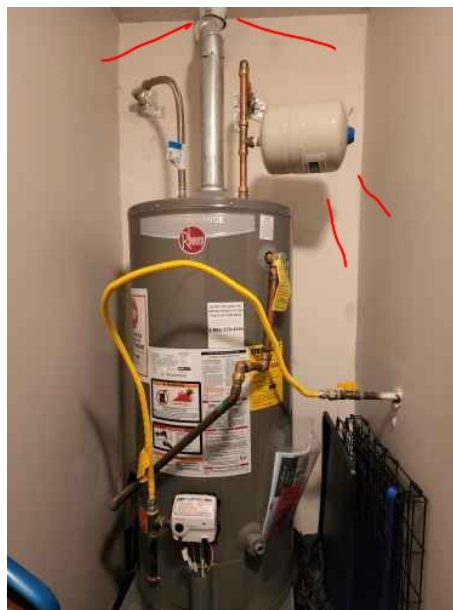
Most expansion tanks are designed to be mounted vertically (up or down) unless specified by the manufacturer and this unit is mounted horizontally which will shorten its lifespan. It's also mounted to the hot side and mounting to the cold side is the normal recommendation.

Water heater wall thimble is missing.

Recommend further evaluation by a qualified plumbing or water heater contractor.

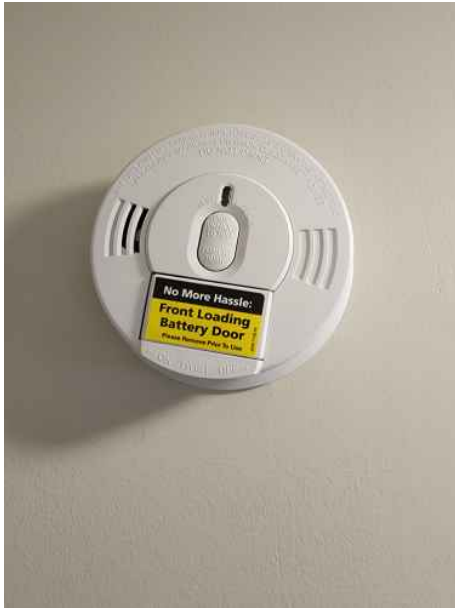
Located in the kitchen, hallway, and in between the master and adjacent bedroom. These are combo carbon monoxide and smoke detectors.

Recommend to test weekly to ensure proper function
