Victory Property Inspections

August 5th 2022, 12:25 pm

General Information

BUILDING ADDRESS: 1000 Mid Town
CITY: Atlanta
STATE: Ga
ZIP CODE: 30067
INSPECTION DESCRIPTION: Mid rise condo 800sq ft, 1bedroom, 1 bath. Built 2001, with 1 garage parking spot. Buyer present
SQUARE FOOTAGE: 800

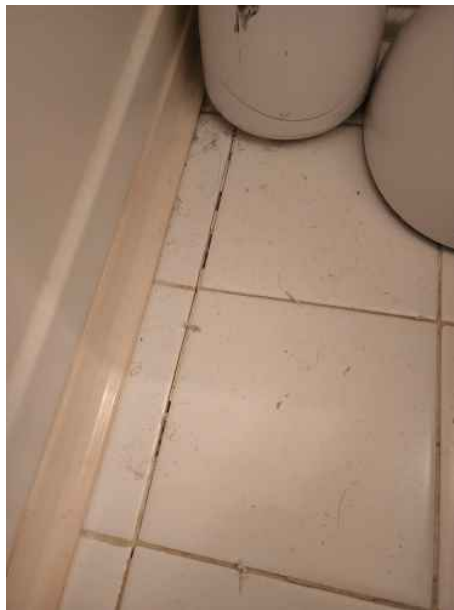
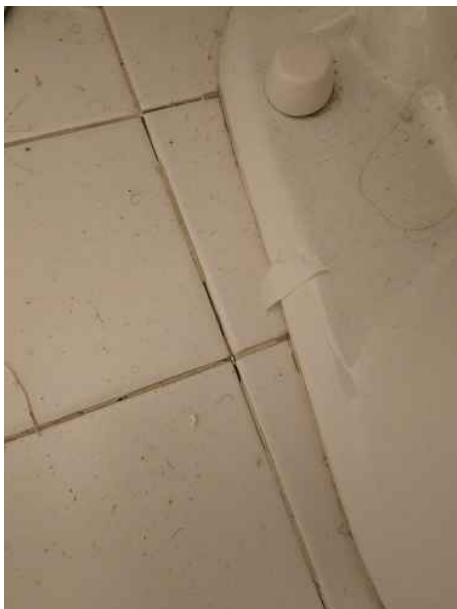
Tiles missing grout to the left of the toilet seen in 2nd and 3rd photos.

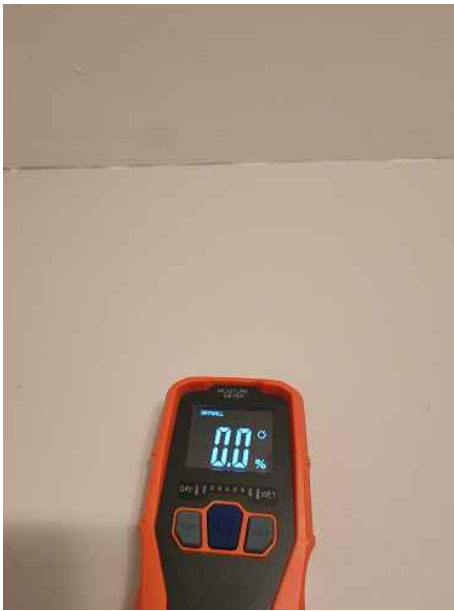
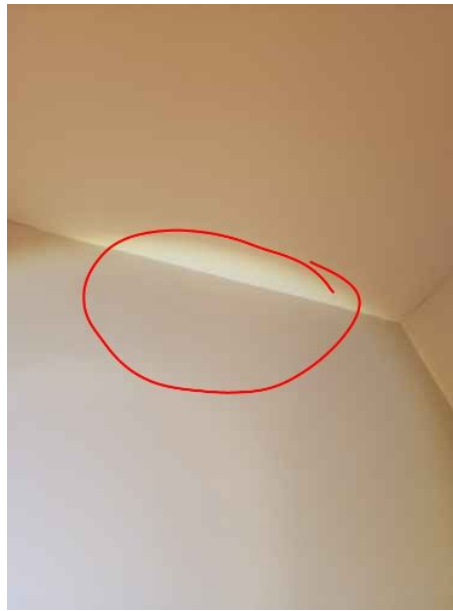
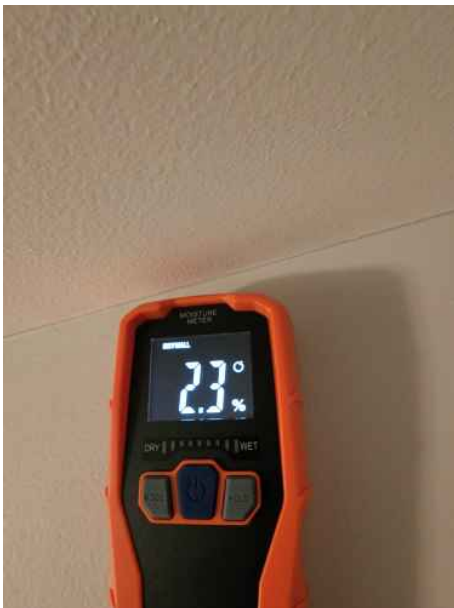
Wall above door shows signs of previous repair, spot was checked with moisture meter seen in first photo and showed no signs of active water leak. Cosmetic issue

Wall above shower head shows signs of previous water exposure, moisture meter did not detect any active leaks seen in 2nd and 3rd photo. Cosmetic issue

Note Multiple walls show signs of previous water issue, no active leaks were observed during the inspection

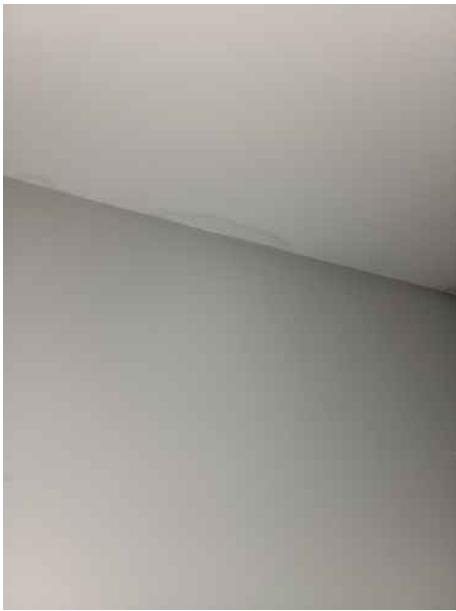
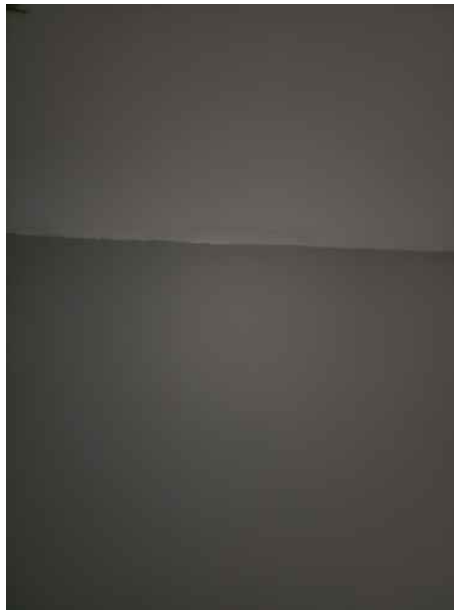
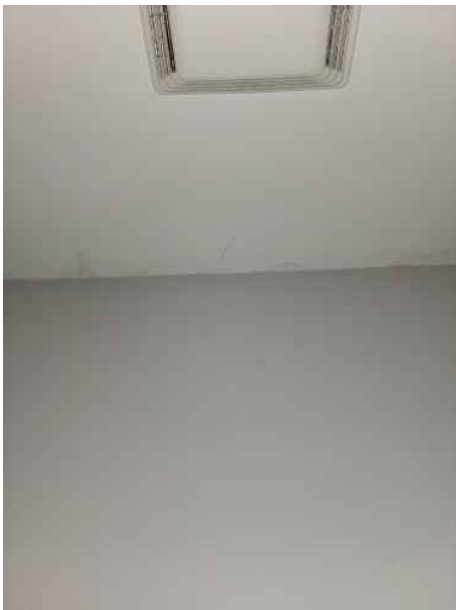
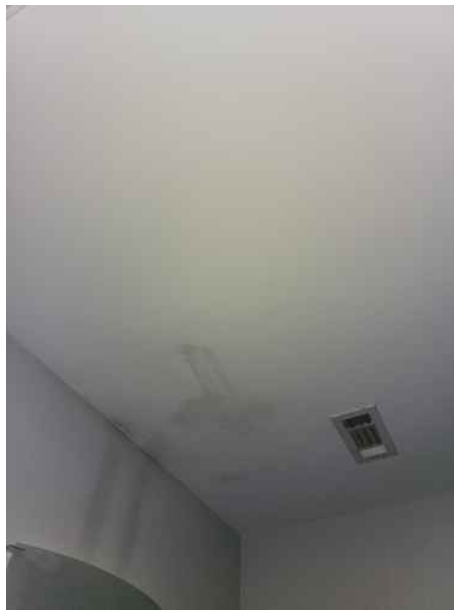
3-4 spots against the back wall show signs of previous water damage seen in photos, no active water leaks were observed.

Paint or some substance smeared on ceiling seen in 4th photo, cosmetic issue

note if in question ask current owner of past water damage that was repaired.

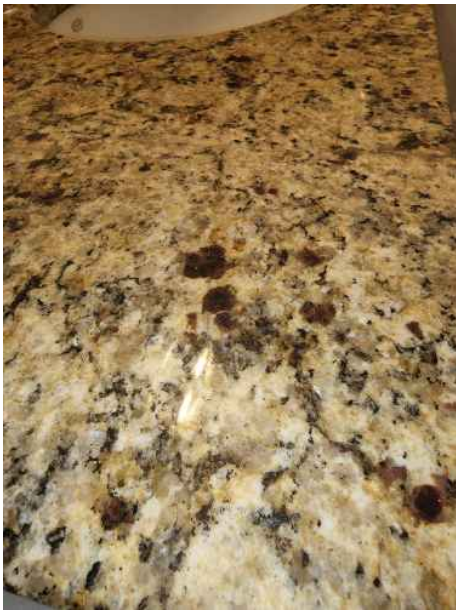
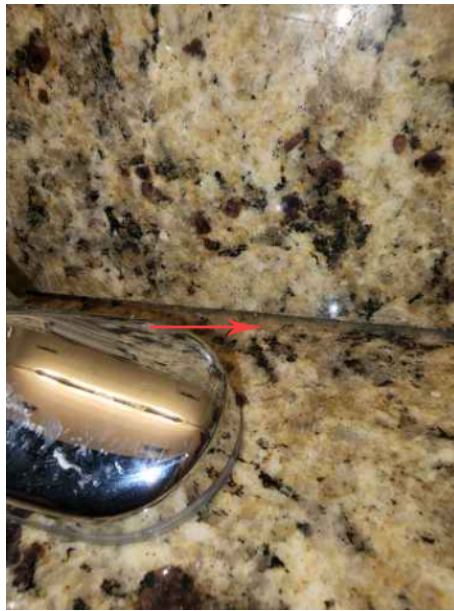
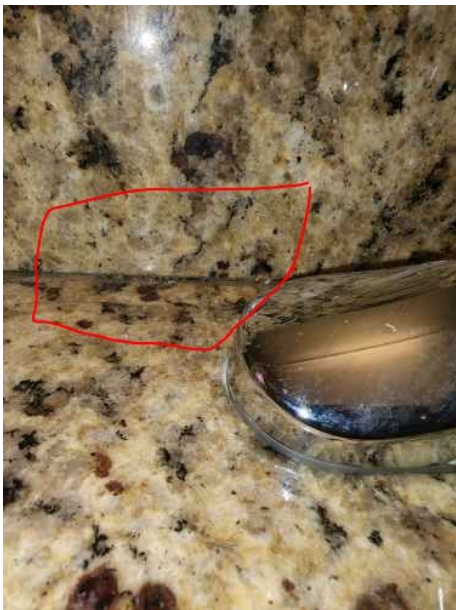
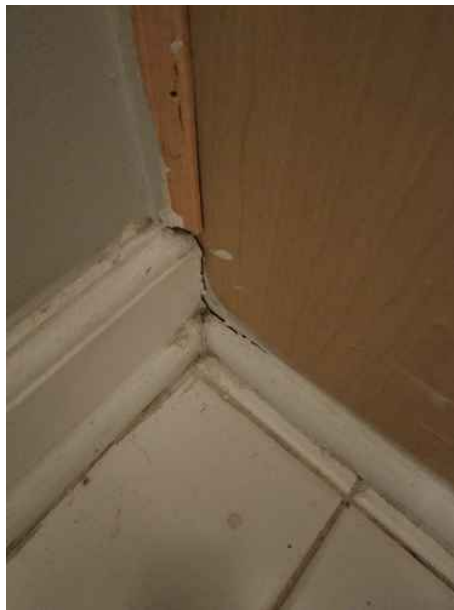
Sealant or caulking is missing behind the bathroom sink. Some areas are sealed but it'd be a good practice to remove existing sealant and replace all new at one time

Sealant missing on left side of counter top base that connects to the trim.

Recommend repair / replacement by a homeowner or handyman.

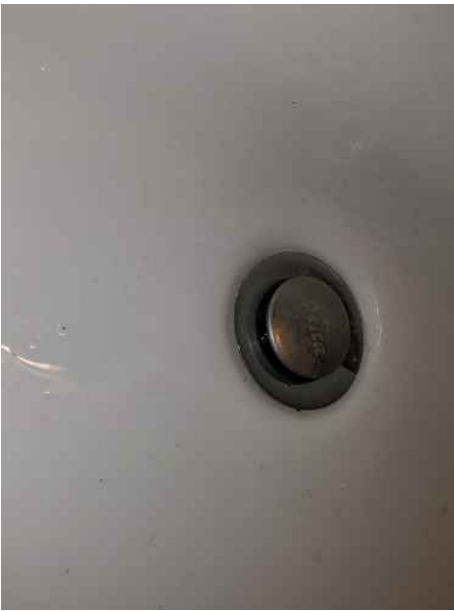
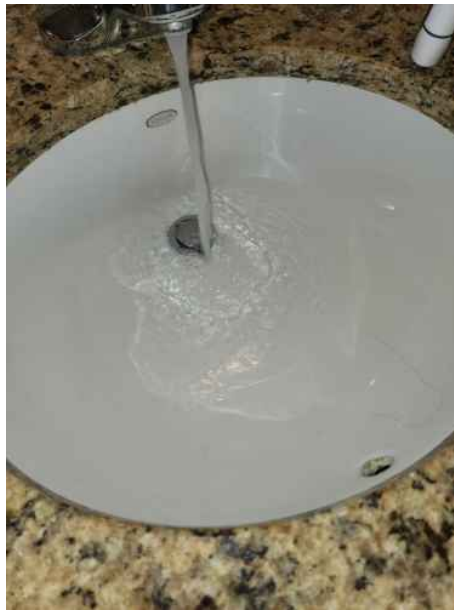
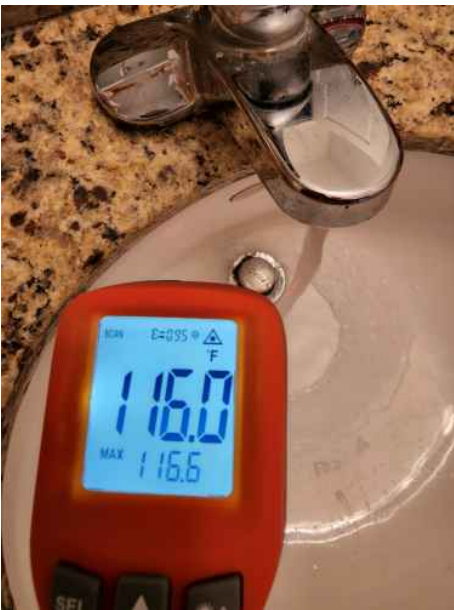
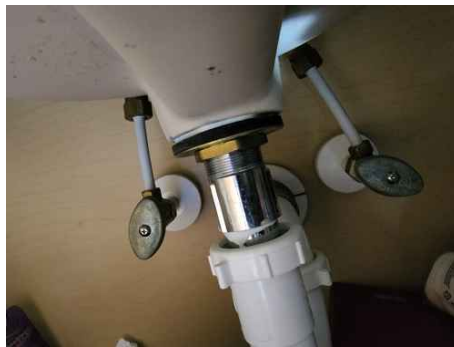
Sink stopper does not seal to allow water to accumulate. Recommend repair / replacement by a homeowner or handyman.

120 degrees is the recommended in home water temperature by the EPA. This temp helps eliminate the risk of bacteria and can be adjusted at the water heater by the homeowner or a qualified handyman.

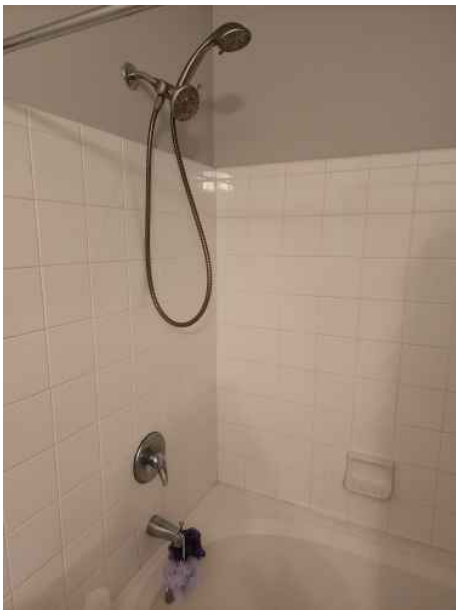
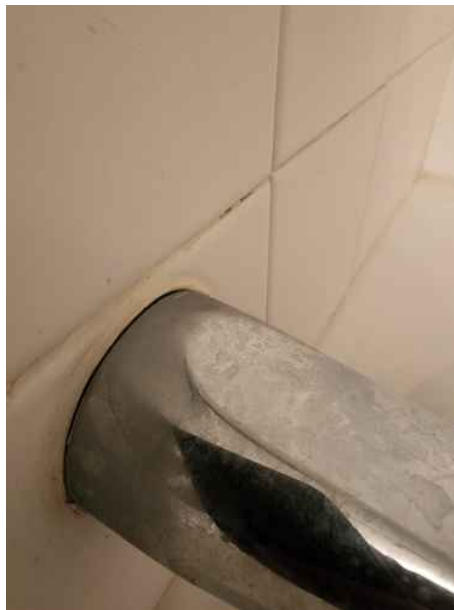
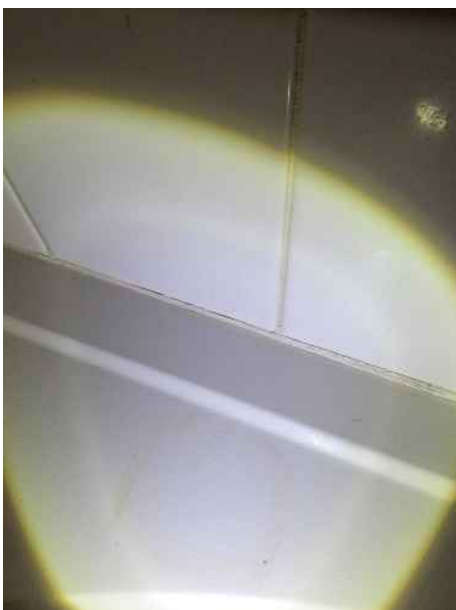
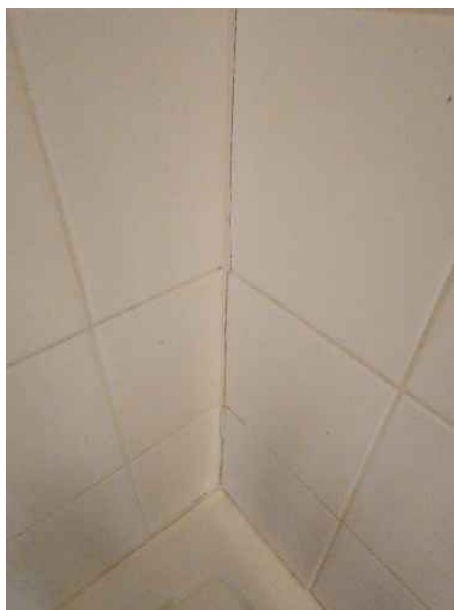
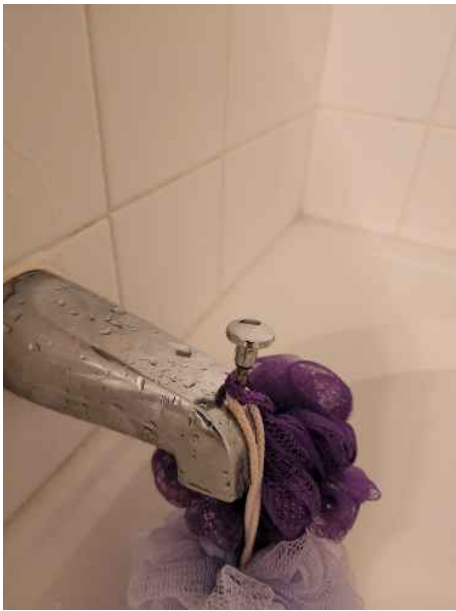
Multiple areas of caulking or sealant that has deteriorated was located in the corner of the shower and a few spots at the base of the wall that connects to the tub.

Caulking missing around the base of the tub faucet.

Shower function located on top of the tub faucet did not operate correctly under normal circumstances. (Very stiff)

Recommend repair / replacement by a homeowner or handyman.

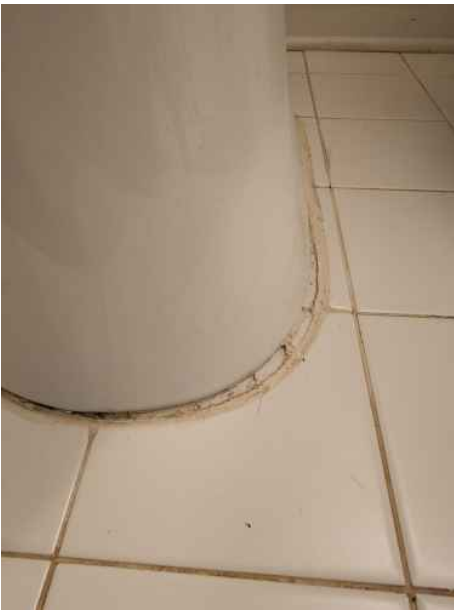
Floor seal around toilet should be replaced to prevent any water intrusion into the floor. Seen in 3rd photo

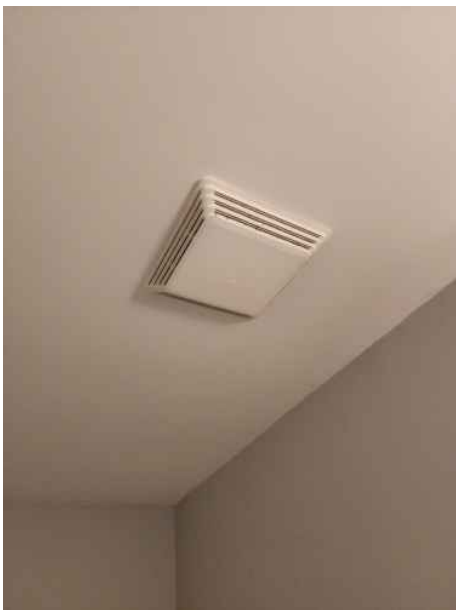
One ceiling vent in the bathroom. Unit is at the end of its life (slow to function and loud) and should be replaced by homeowner or a qualified handyman.

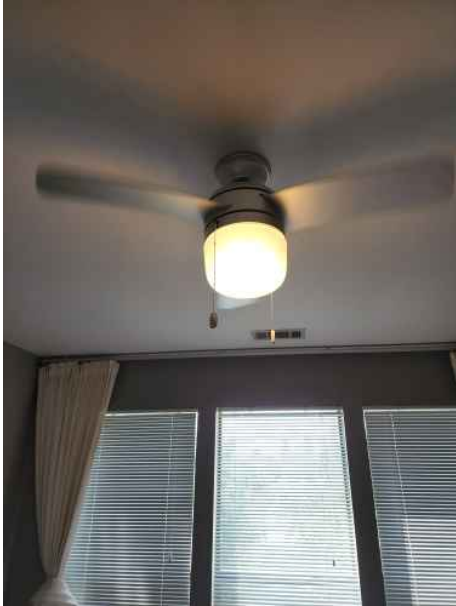
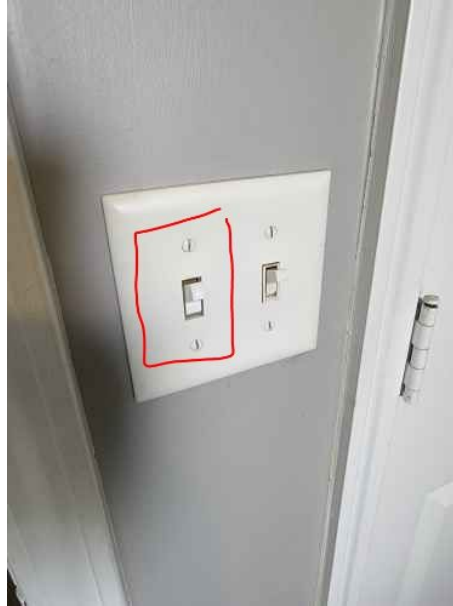
Outlet switch on the left circled in photo does not have a function. Light and fan operated using the switch on the right.

If in question, Recommend further evaluation by a qualified electrician or contractor.

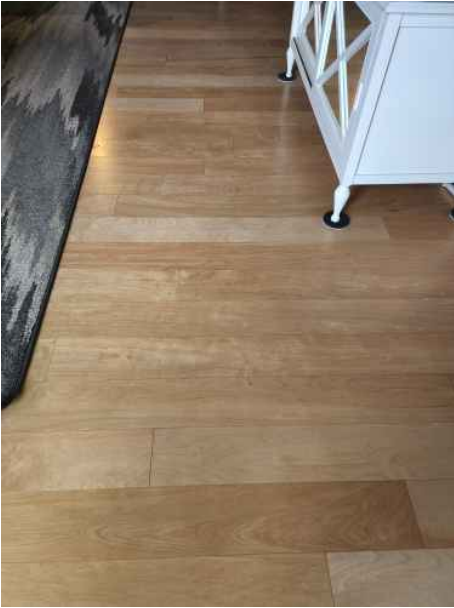
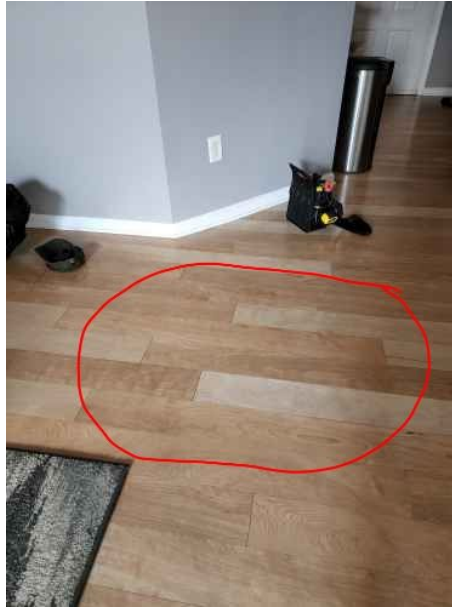
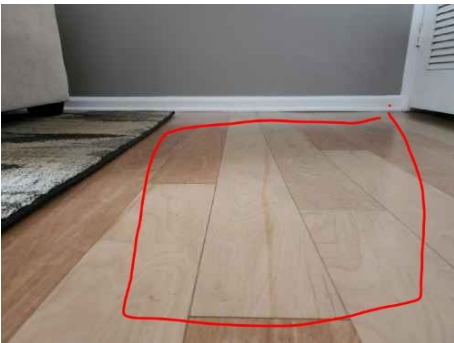
Floor located by mechanical room is not level and floor boards "give" when walked over. Most likely caused by insufficient underlayment.

Recommend repair / replacement by a homeowner or qualified flooring contractor.

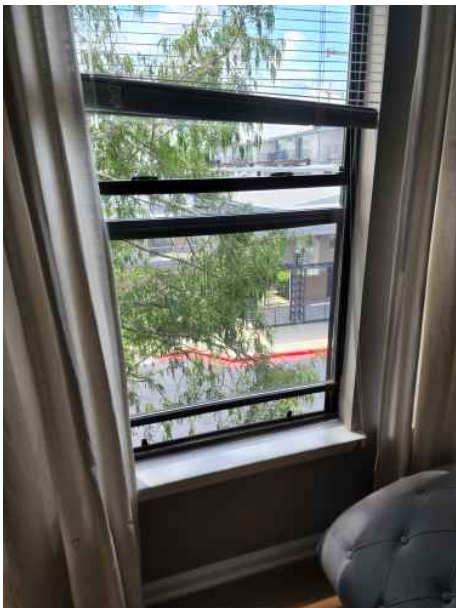
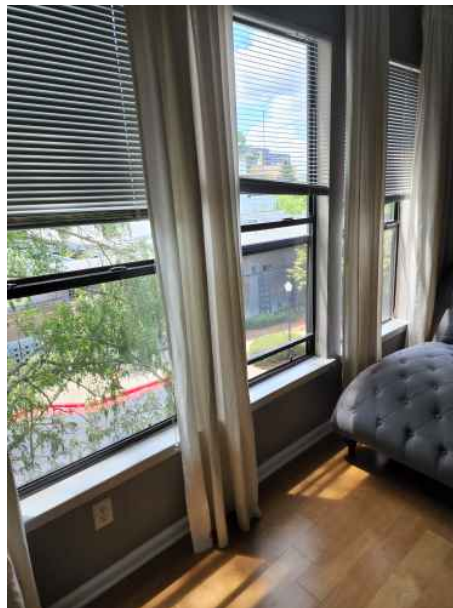
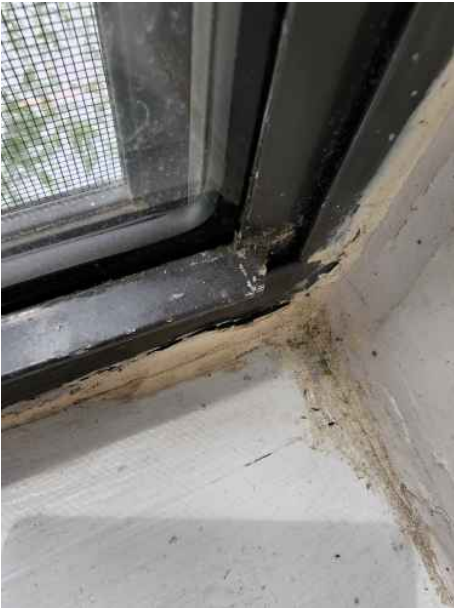
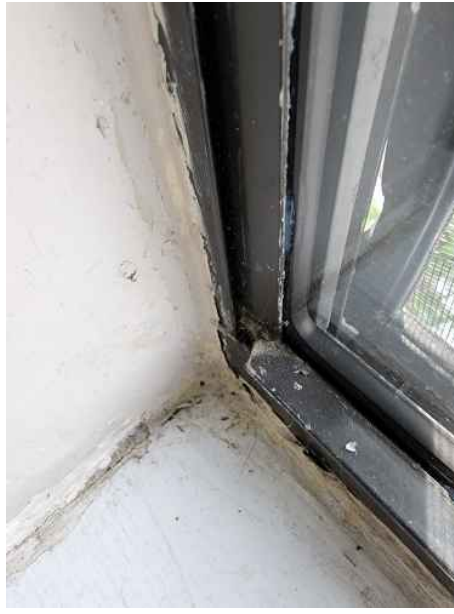
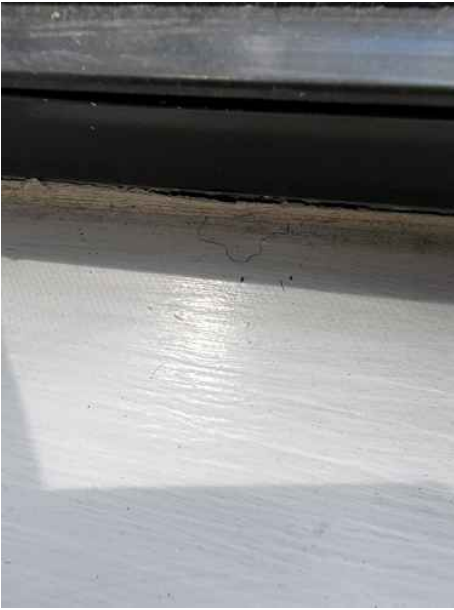
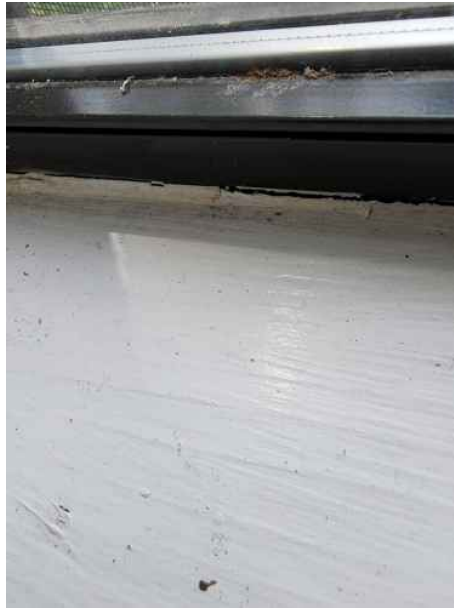
Caulking around all windows in the living room show cracks or deterioration and should be re-caulked or sealed. All windows did operate correctly.

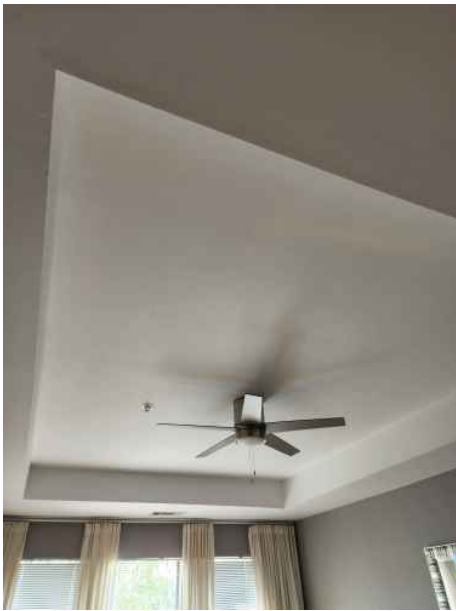
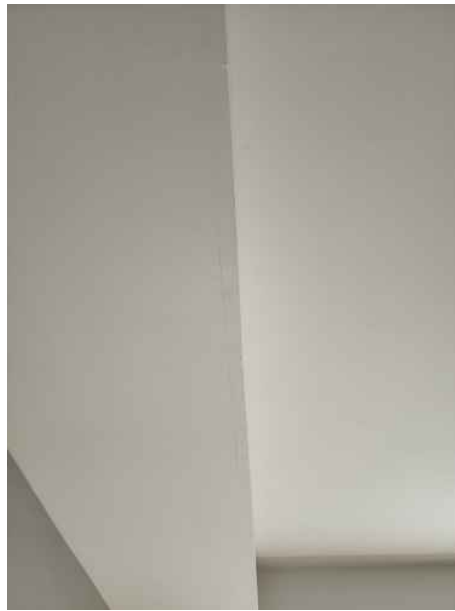
Crack observed on left side ceiling, most likely due to movement of the building and should not cause alarm.

Recommend to monitor for any changes.

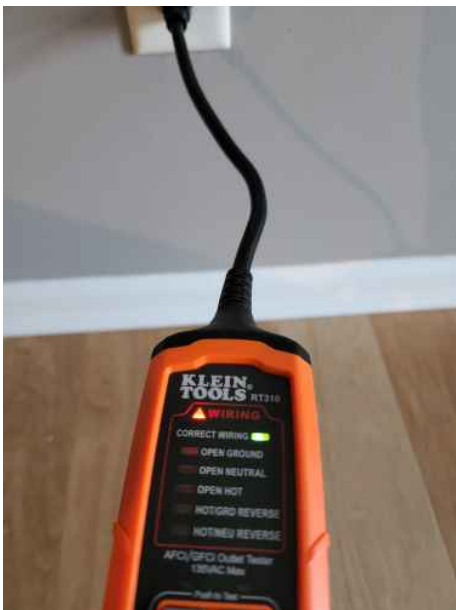
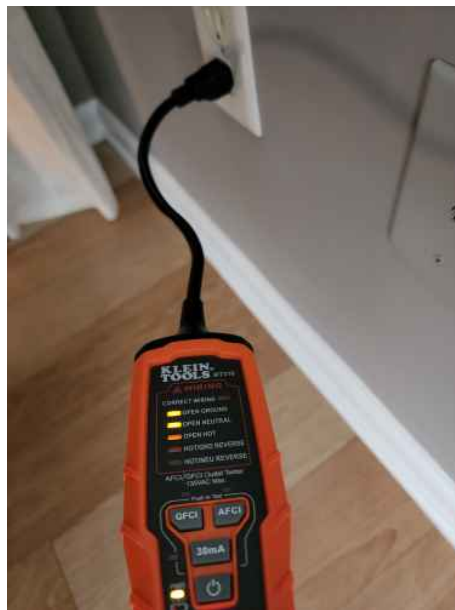
Bottom outlet located on right side of the living room has an open ground and open neutral that can be seen in the second photo causing this socket to not operate.

Recommend further evaluation by a qualified electrical contractor.

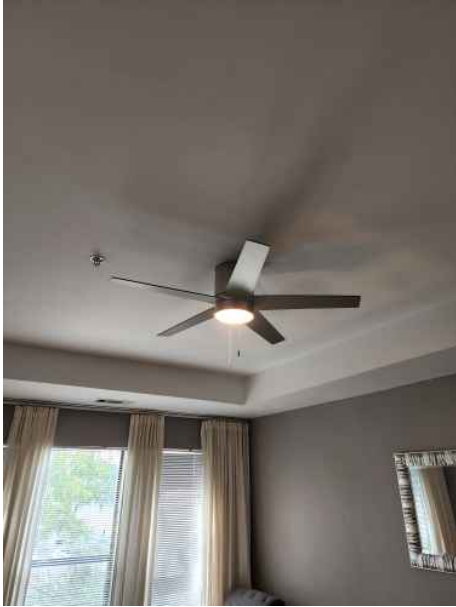
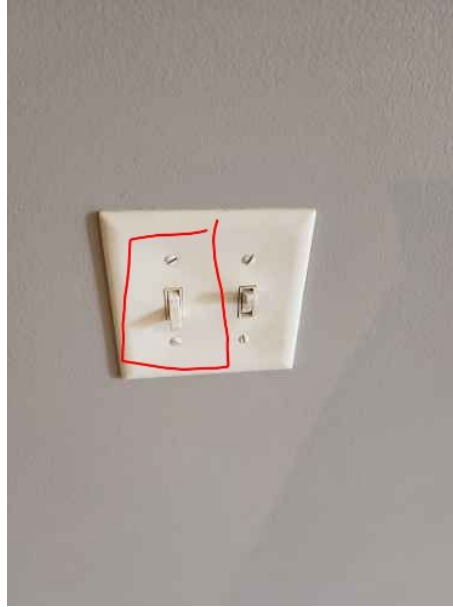
Note that like the bedroom the first switch highlighted in photo has no function.

Recommend to have a qualified electrician complete repairs.

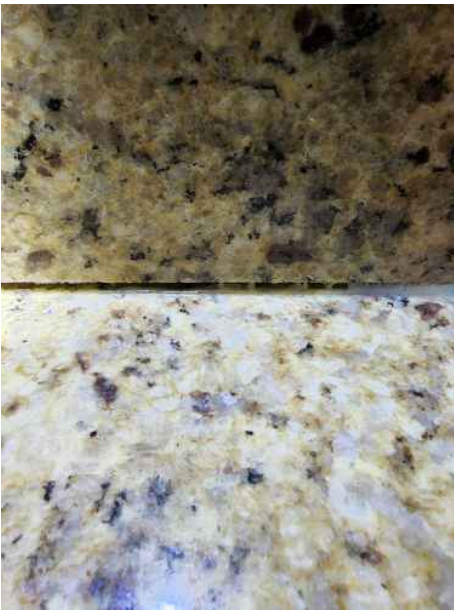
Sealant behind kitchen sink needs to be replaced, seen in first photo.

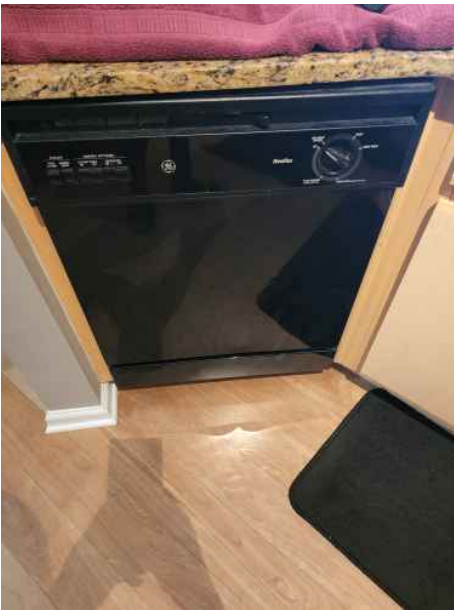
Did not function under normal operating conditions. Recommend repair / replacement by a homeowner or handyman.

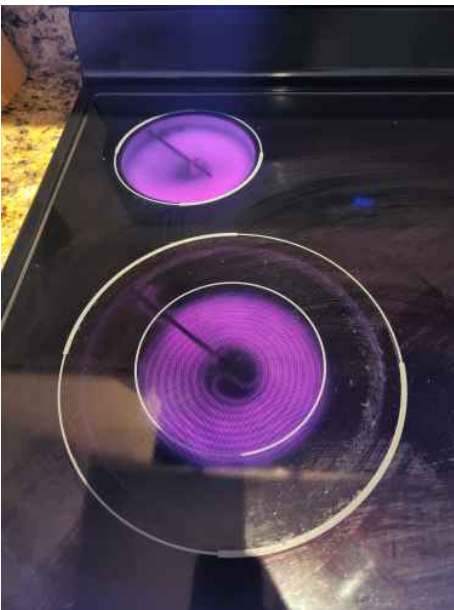
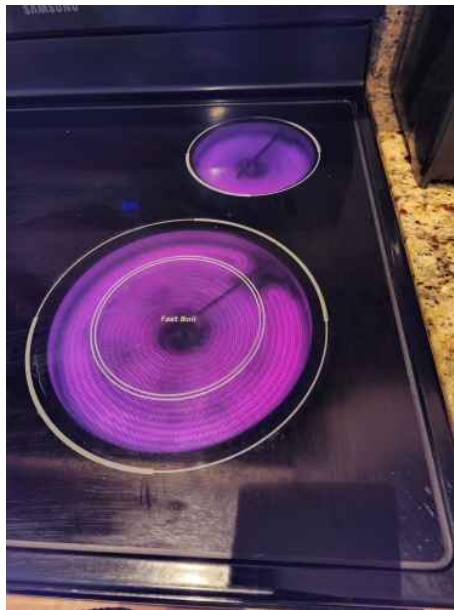
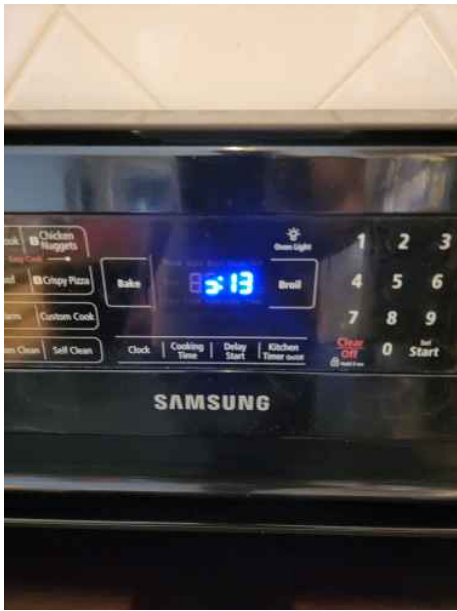
Display on stove isn't functioning correctly. Recommend further evaluation by a qualified contractor.

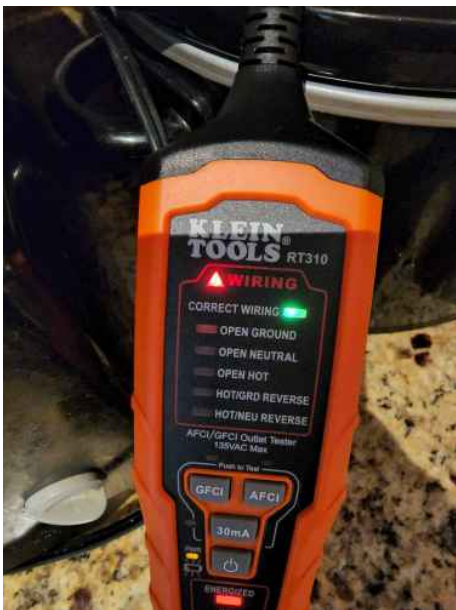
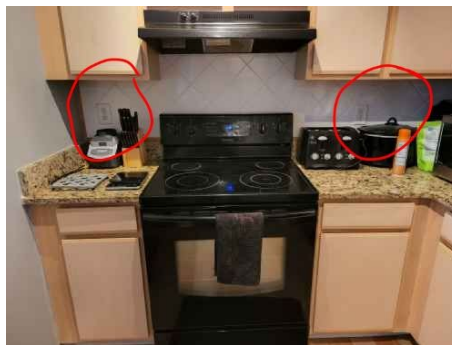
Both outlets on the side of the stove/oven should be gfcı due to their proximity to the sink. Recommend repair / replacement by a homeowner or handyman.

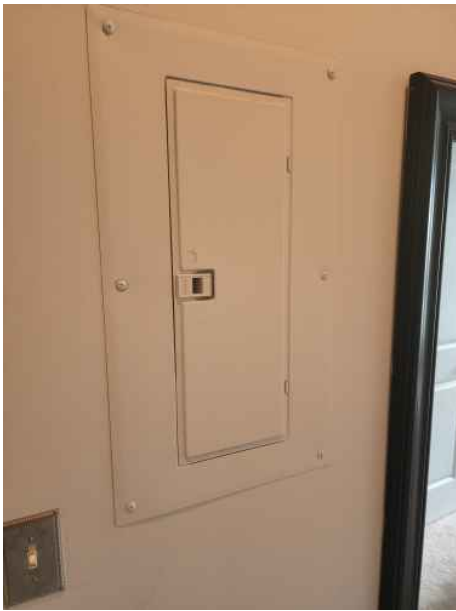
Unable to inspect due to access limitations.

Panel was painted with the wall, removing might cause the paint to be damaged

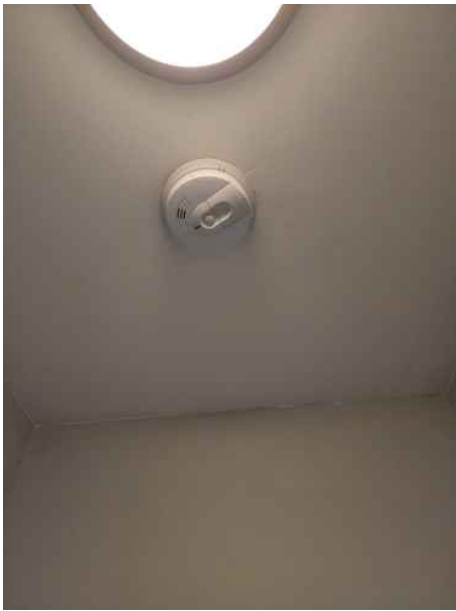
One detector was located outside of the bedroom, the inspector recommends to have an additional one installed in the main living space for safety.
