Victory Property Inspections

General Information

BUILDING ADDRESS: 7777 Superman Hwy
CITY: Atlantis
STATE: Georgia
ZIP CODE: 11223
INSPECTION DESCRIPTION: General Home Inspection
SQUARE FOOTAGE: 2245

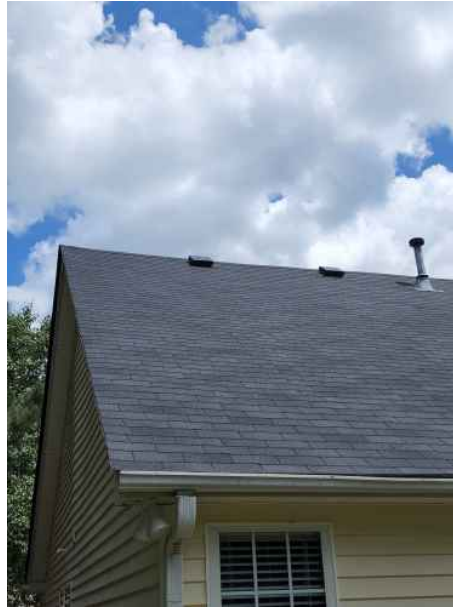
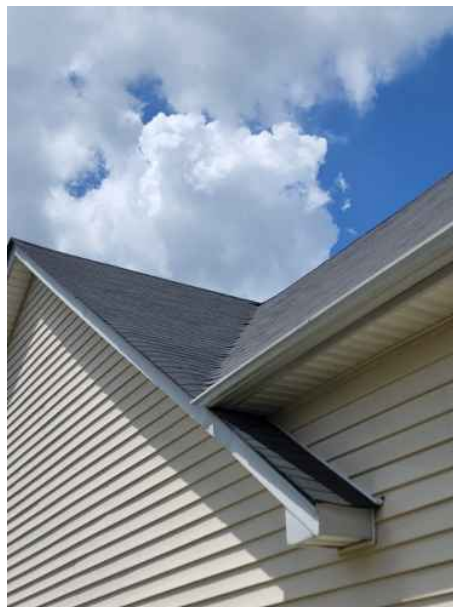
3 tab roof is under one year old, has multiple nail pops due to installation nails not being long enough or possibly contraction and expansion due to climate.

Recommend further evaluation by a qualified contractor.

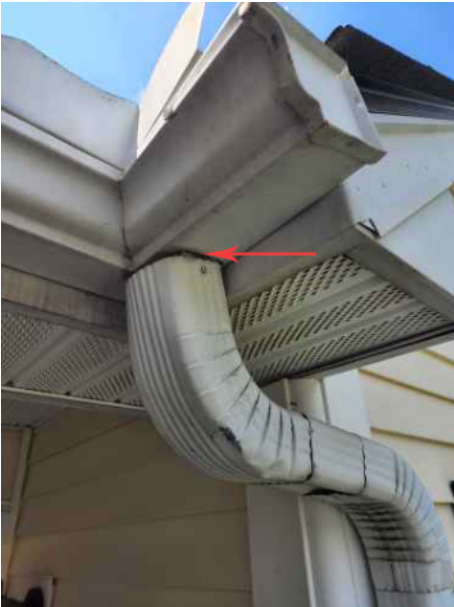
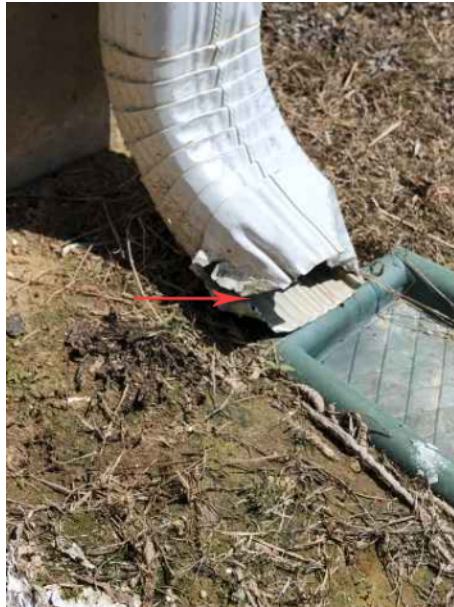
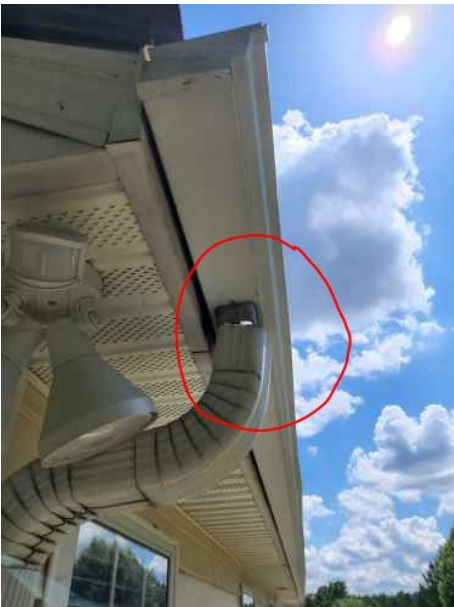
Gutter spout on rear of the home right side (from facing home) is not attached to the Gutter causing improper drainage.

Gutter spout on the left side of home is damaged possibly by a lawn mower. Replacement of lower spout will be required before extension can be added.

All spouts should be repaired by homeowner or qualified contractor

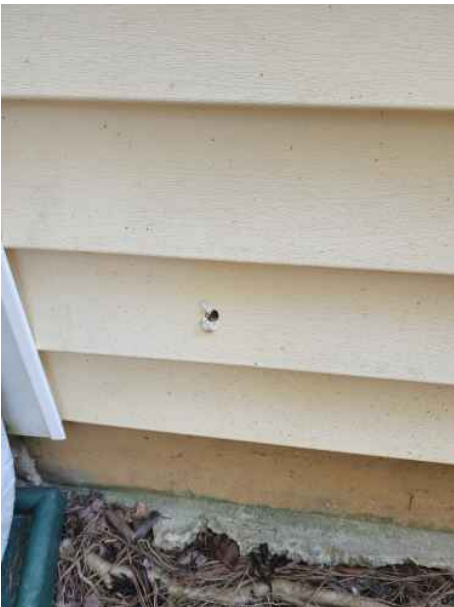
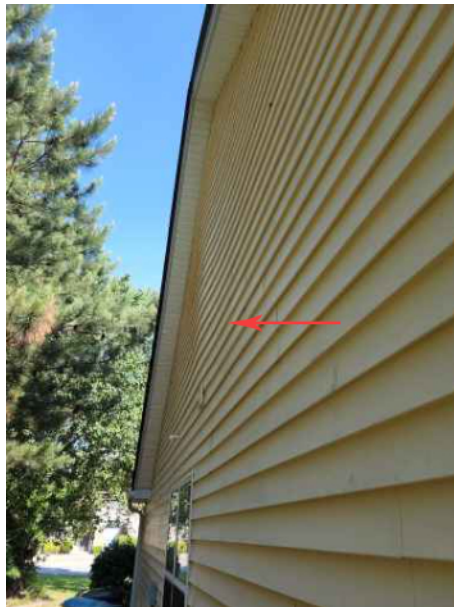
Nickel size hole on right side of house that needs to be sealed to prevent water intrusion and pest.

Vinyl siding on right side of the house is bowed. Many things can cause this like improper installation and also water intrusion. Recommend to have a qualified contractor perform maintenance and also to determine definite cause to prevent further deterioration.

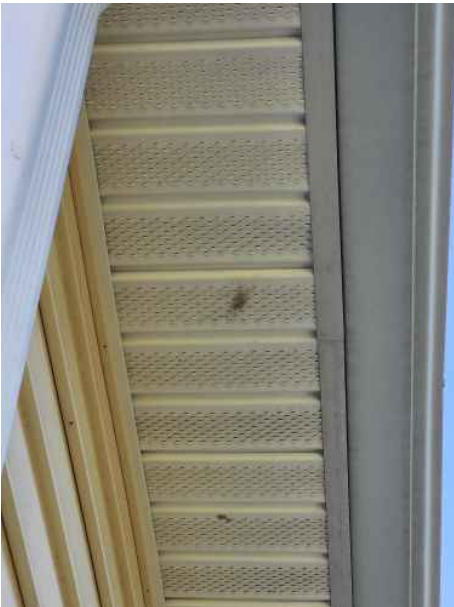
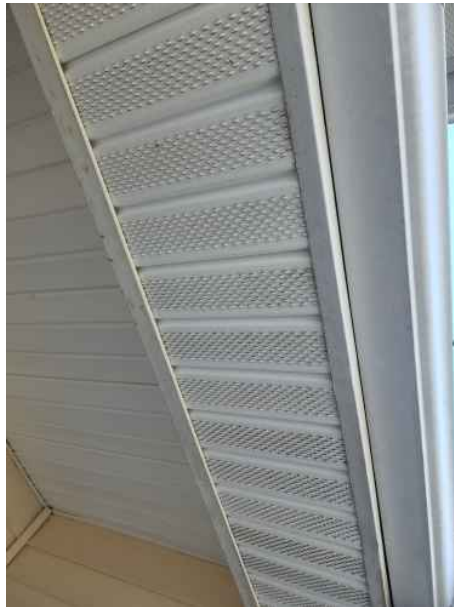
Soffits are in good overall condition and just need to be cleaned, the inspector recommends cleaning your soffiits once every two years with a mild detergent to keep them look clean and also to remove and insects.

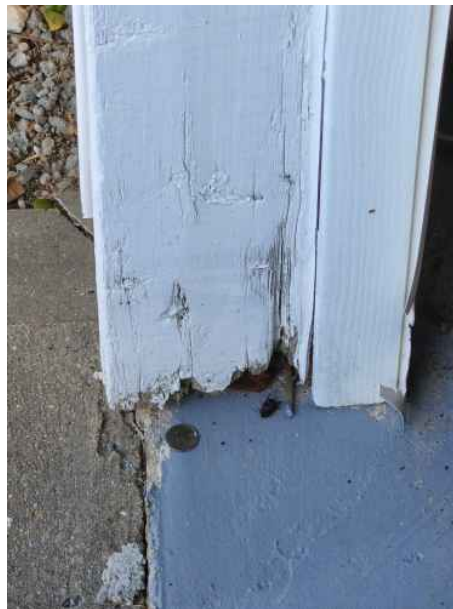
Condition is typical for an item of this age and the deterioration of the wood trim can be seen in a few photos below. (Front door, and garage door trim pictured below)

Note If planning on painting the exterior of the home also plan on having new trim installed at the same time. Trim can be repaired in most instances and due to the age of this trim it would be best to have it replaced.

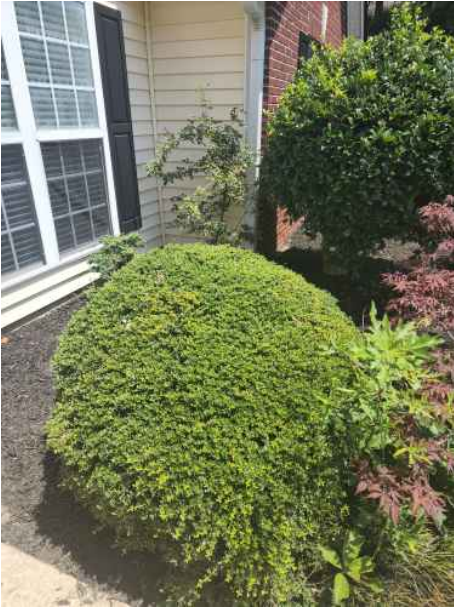
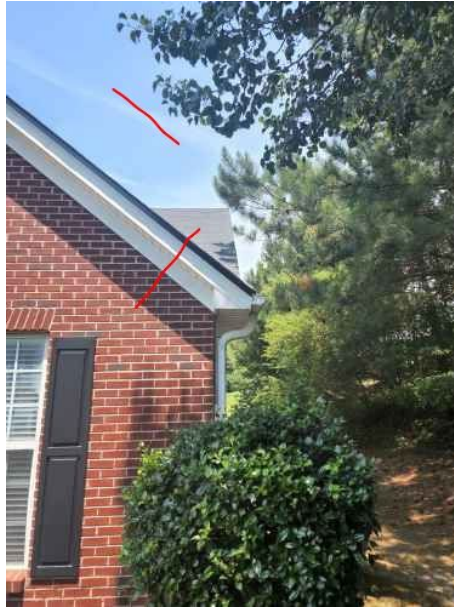
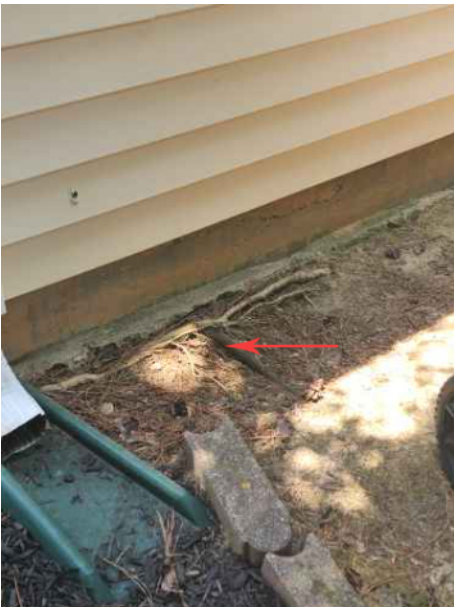
Tree root is located right next to the slab on the right side of the home. Roots can disturb and cause cracking although no damage was seen at the time of inspection. Recommend to monitor and or have removed for peace of mind.

Tree limbs can be seen in photo growing above the roof line, this can cause the leaves or debris to accumulate in the gutters causing blockage or damage if enough accumulates. Recommend to have the branches regularly trimmed to prevent any issues.

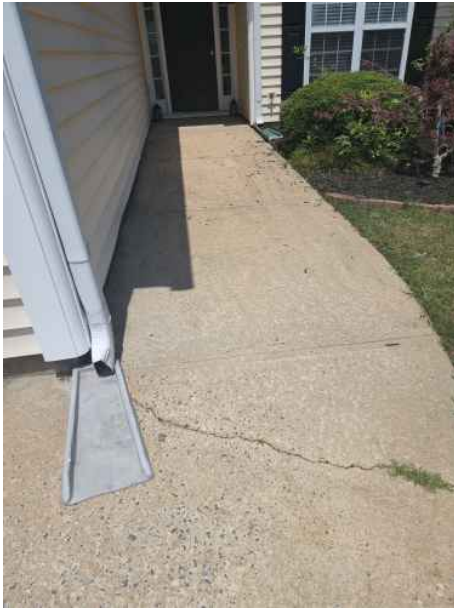
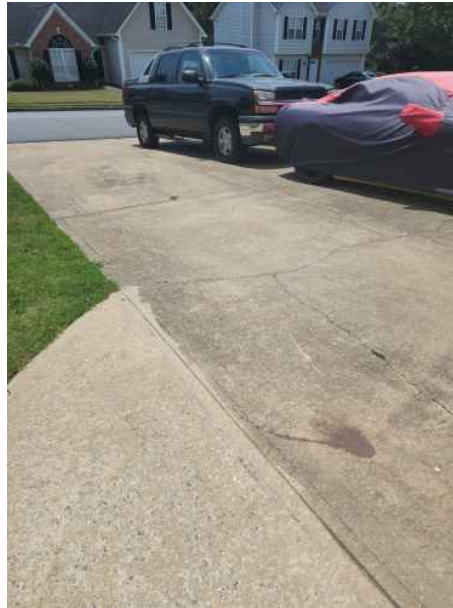
Surface cracks in the walkway were observed but are typical and not cause fir alarm.

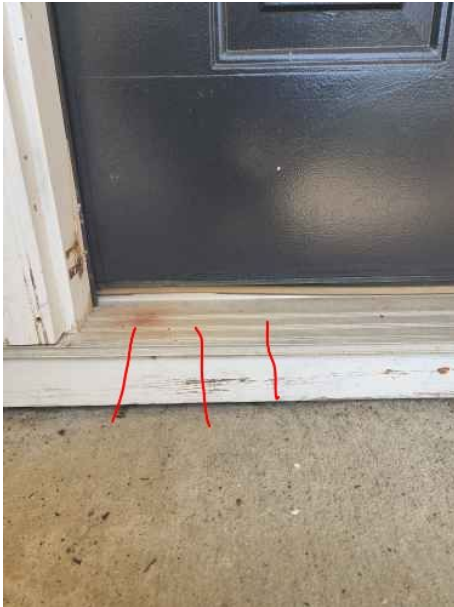
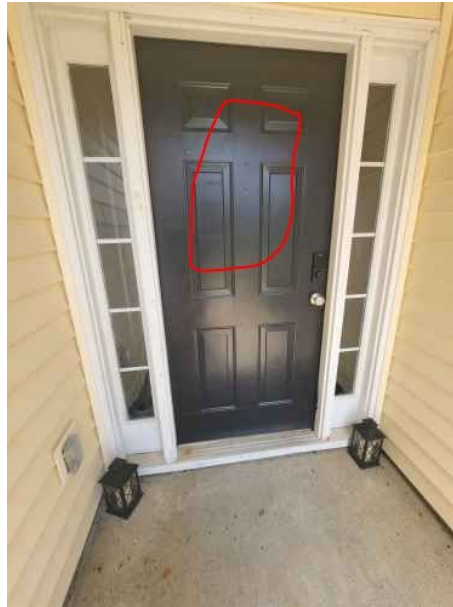
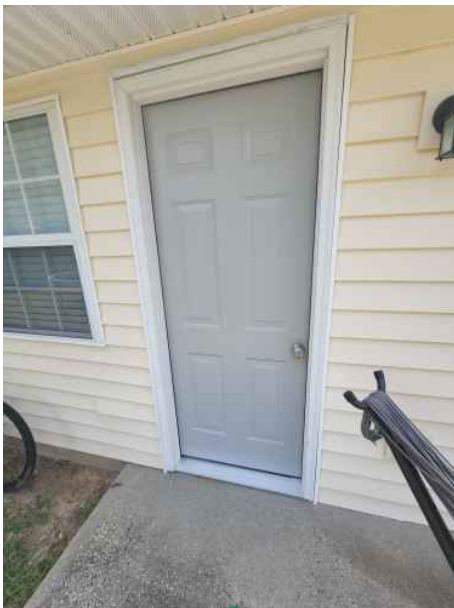
Front main entry door has two holes drilled through that serve no purpose. These holes will allow bugs and air in and out of the home. This door also needs to have the weather stripping repaired/replaced to prevent water intrusion.

Recommend further evaluation by a qualified contractor.

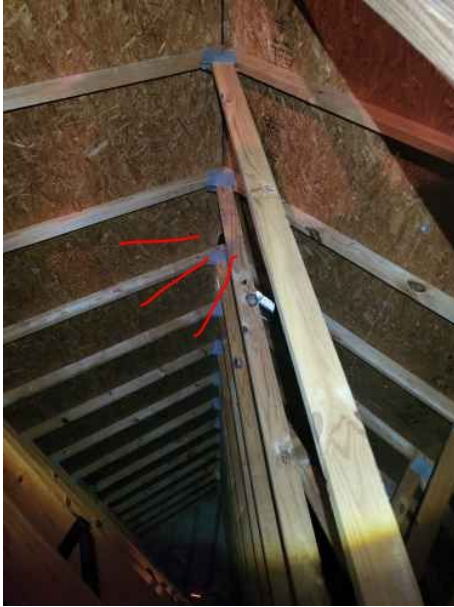
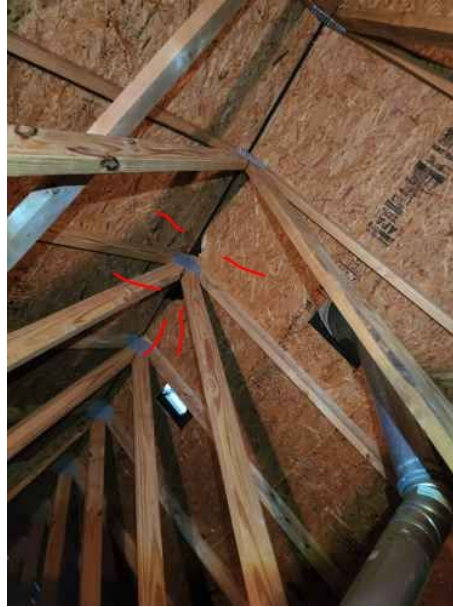
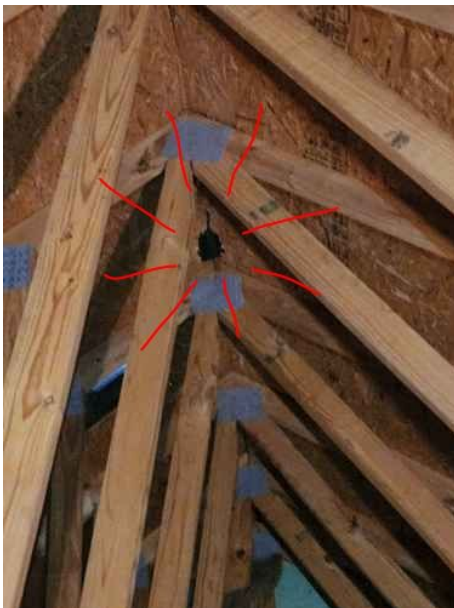
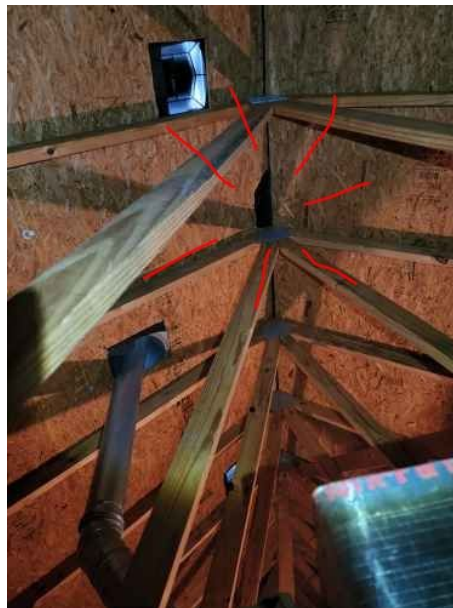
Multiple damage areas were observed in the roof sheathing seen in photos. These areas can cause things like inadequate heating and cooling, water damage, mold ect.

Recommend further evaluation and repair by a qualified contractor or roofing company.

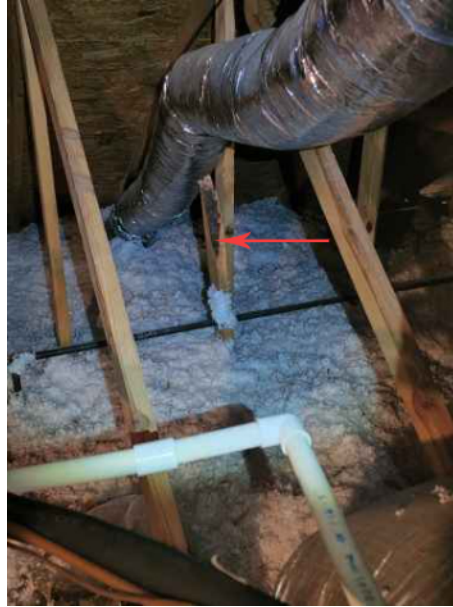
Damage was observed on one of the roof trusses, recommended further evaluation and or repair by a qualified contractor.

Also noted was a one piece of frame work that is not attached to anything. Appears this was done when the home was built and is not something to be alarmed about, just something for the owner to know.

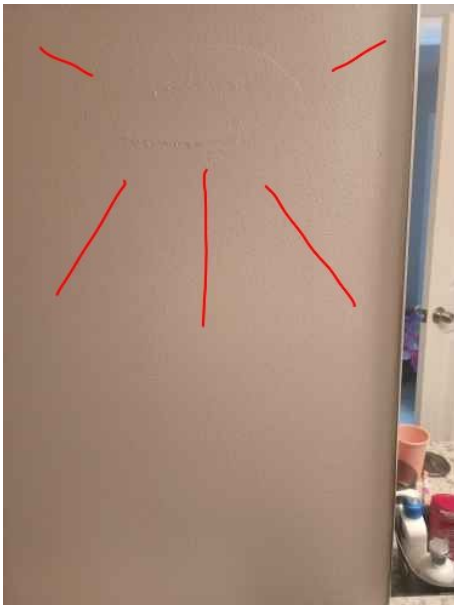
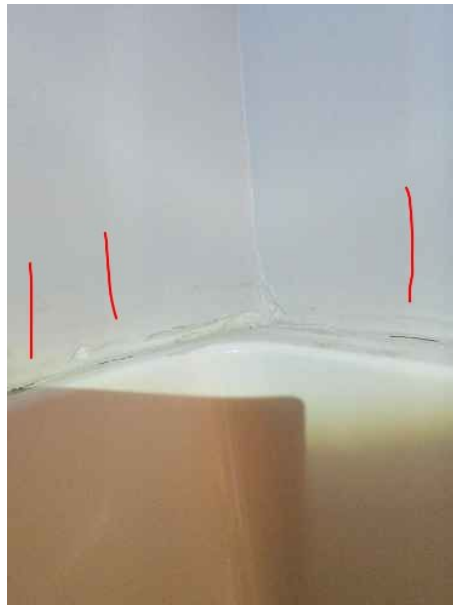
Previous areas of repair were observed, at the discretion of the owner I recommend to have these spots sanded, primed, and painted. (Cosmetic issue)

Right corner above tub surround is missing caulking and should be replaced by the owner or a qualified contractor.

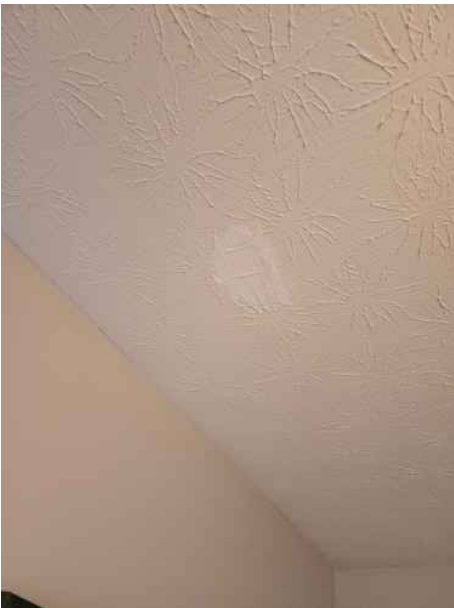
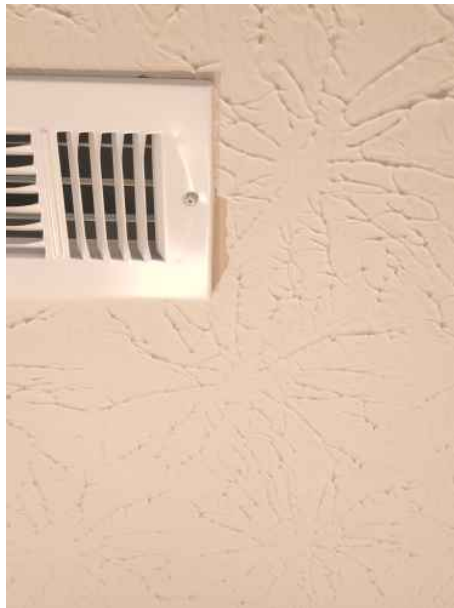
Suspected previous water damage spot was located on the ceiling. No current water leak was present. Recommend to have this spot sanded, stained, and repaired properly. (Cosmetic issue)

Chipped paint next to the ceiling register seen in photo. (Cosmetic issue)

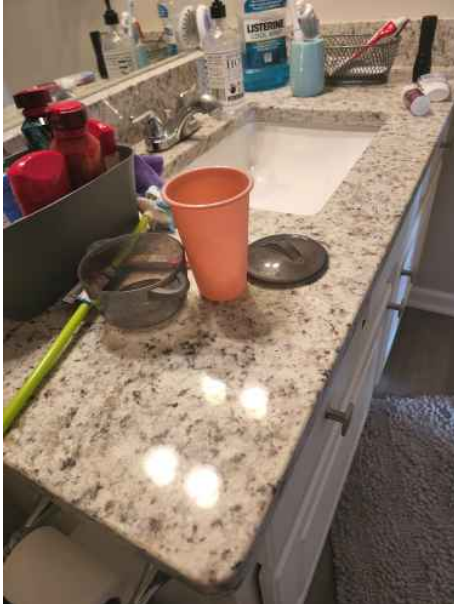
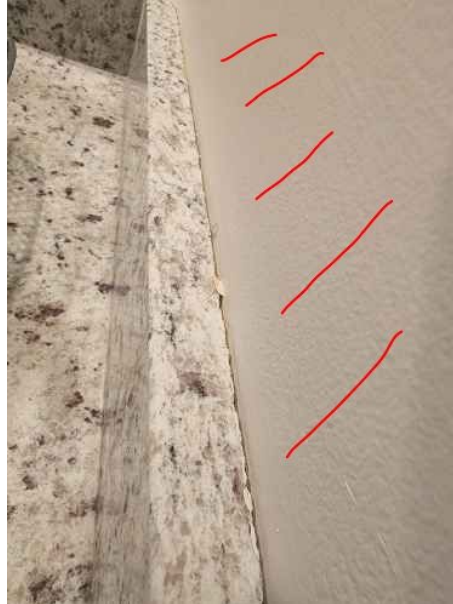
Right side of the counter top is missing sealant or caulking. This caulking will prevent water from the sink getting in between the counter and wall causing damage/rot/mold ect.

Recommend repair / replacement by a homeowner or handyman.

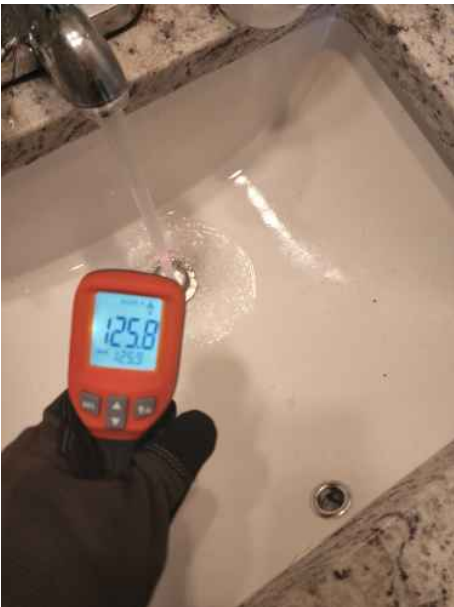
Handle on sink stopper in guest bathroom is broken and just sitting on top of the rod. Stopper does function as needed seen in the photos.

Recommend repair / replacement by a homeowner or handyman.

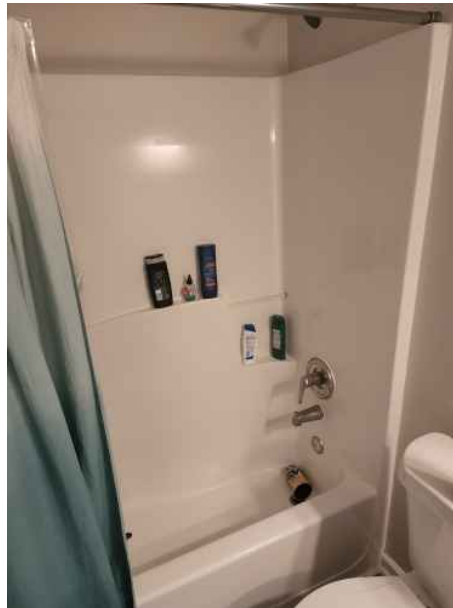
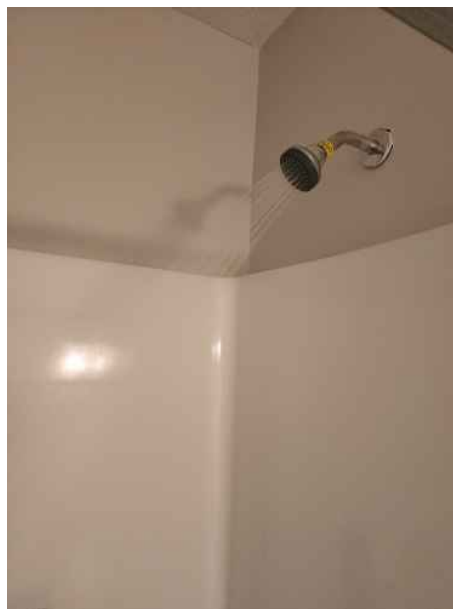
Sealant is missing around the shower head to the wall.

Tub stopper/boot plug is missing.

The shower has a small Drip or leak once the handle is closed and needs to be closed just right for the water to stop flowing.

Recommend repair / replacement by a homeowner or handyman.

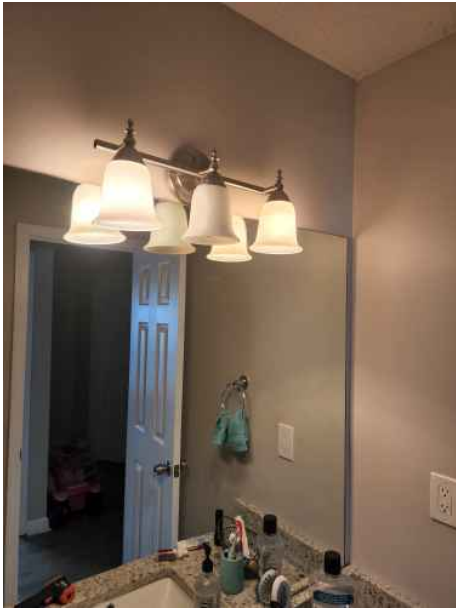
One light bulb was out but was tested with the inspectors light bulb and the socket functioned properly

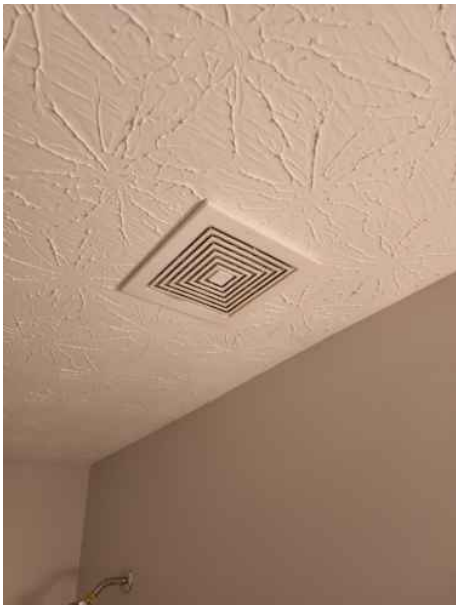
Bathroom vent is extremely loud and most likely at the end of its life span.

Recommend repair / replacement by a homeowner or handyman.

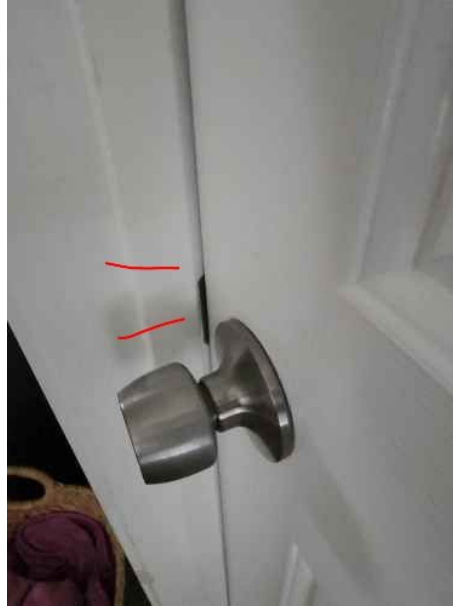
Door does not shut completely when closed and an extra push or pull is needed.

Recommend repair / replacement by a homeowner or handyman.

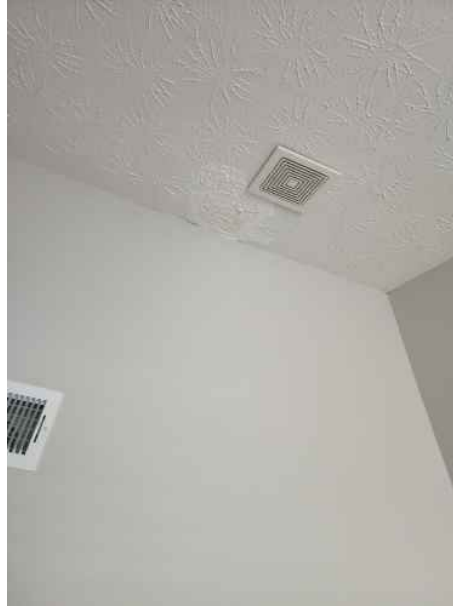
Poor job at doing a ceiling repair from most likely water damage can be seen. No current water leak was observed at the time of inspection.

Ceiling paint has chipped, or fallen off seen in photo.

Recommend repair / replacement by a homeowner or handyman.

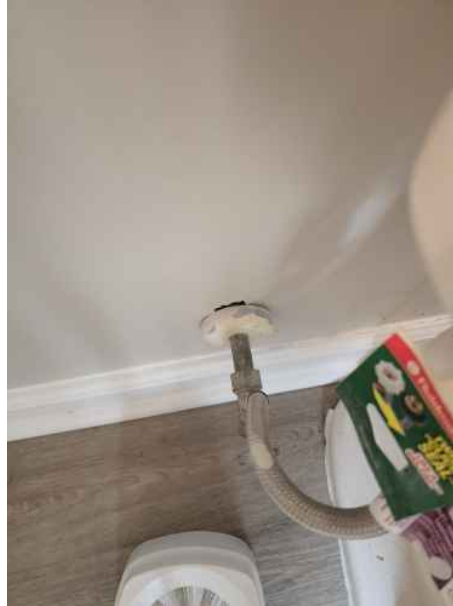
Toilet seat is loose and was tightened.

There is a hole in the wall above the toilet water line cap seen in photo.

Recommend repair / replacement by a homeowner or handyman.

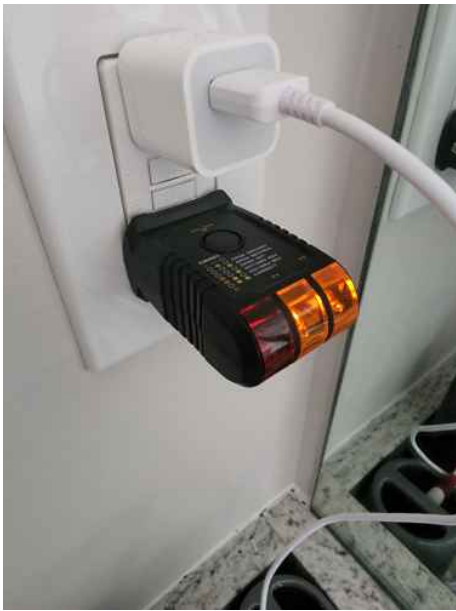
One gfcı outlet was present. During the test function of the outlet it did not reset properly at the outlet and had to be reset using the outlet in the guest bathroom.

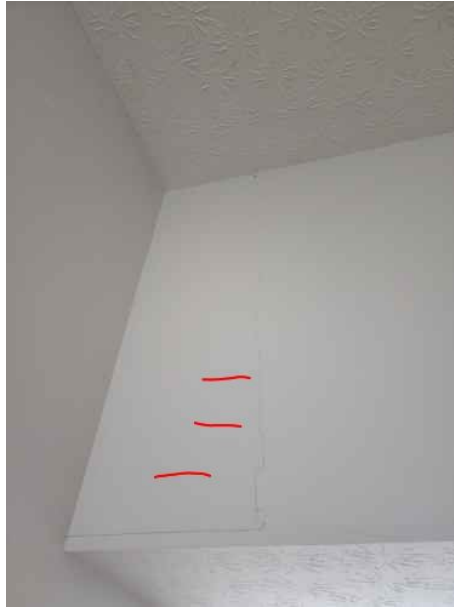
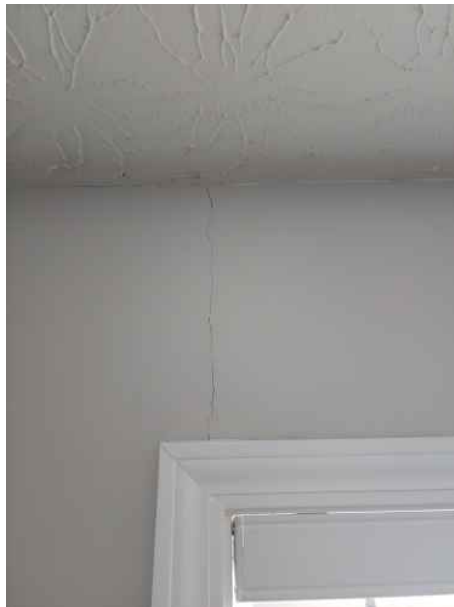
Cracks were observed on the walls in the master bedroom, these could be caused by the house settling and are usually not cause for alarm. In this case due to the size and locations of the cracks the inspector recommends further evaluation to be completed by a qualified building specialist or structural engineer.

In the first photo a nail has been inserted into the wall and painted over, it's purpose is unknown. Recommend repair / replacement by a homeowner or handyman.

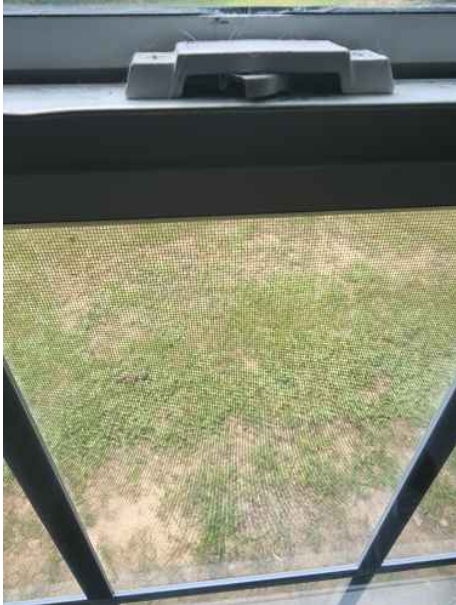
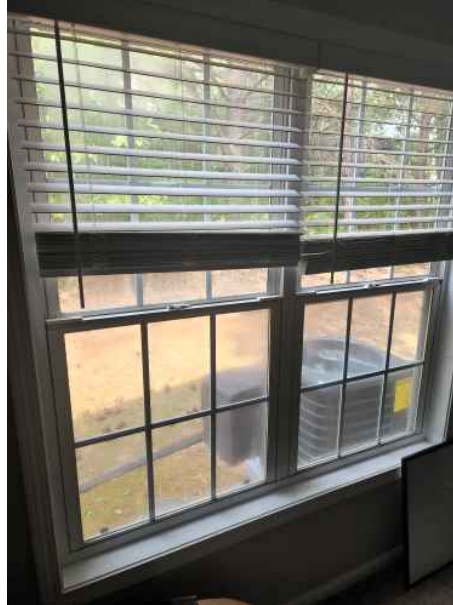
Window lock on left side in the master bedroom is broken. This can be a safety hazard as well as a function issue. Recommend repair / replacement by a homeowner or handyman.

note All windows in and around home have damaged seals and should be replaced or repaired at the home owners discretion

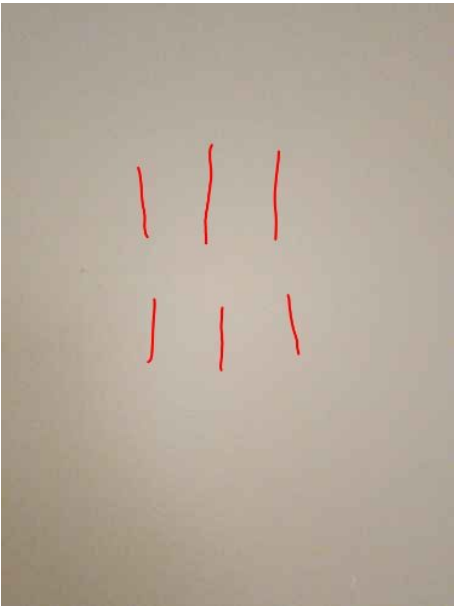
Drywall tape line can be seen all the way around the room.

Continue to monitor, if condition deteriorates contact a qualified contractor.

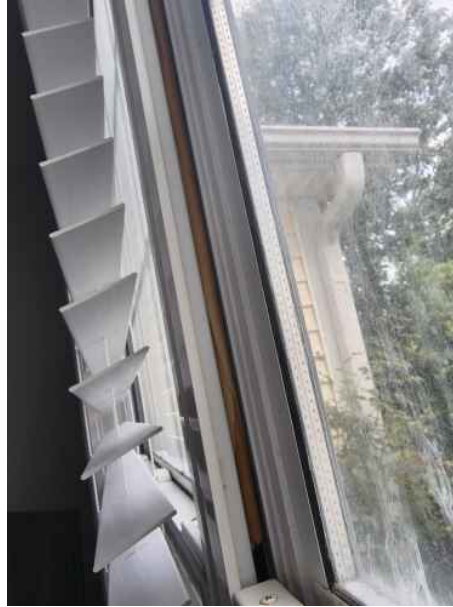
WINDOWS Poor

Window lock on the left side is broken and needs to be replaced.

One damaged window seal can be seen in the second photo, this is likely the condition of all windows located around the home. Please see note below

note All windows in and around home have damaged seals and should be replaced or repaired at the home owner's discretion

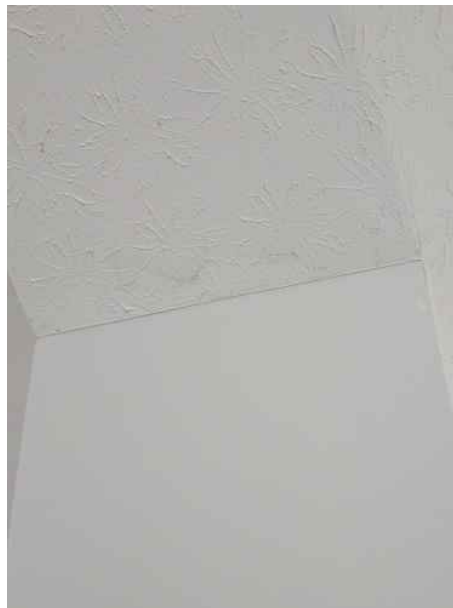
CEILING Fair

Previous water stains were observed on the ceiling in the living room, no water leaks were present at the time of inspection.

Recommend repair / replacement by a homeowner or handyman.

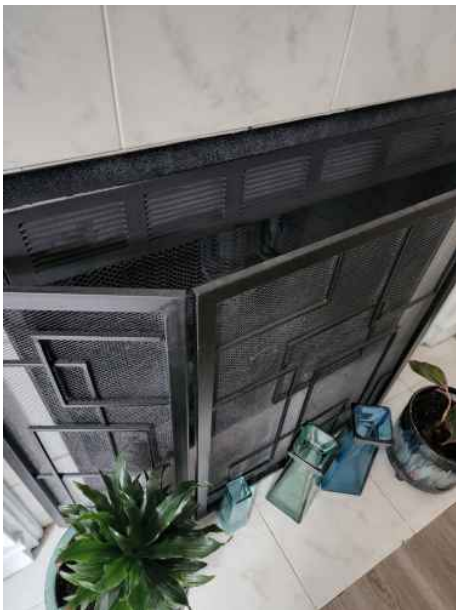
FIREPLACE Not Inspected

Unable to inspect due to access limitations.

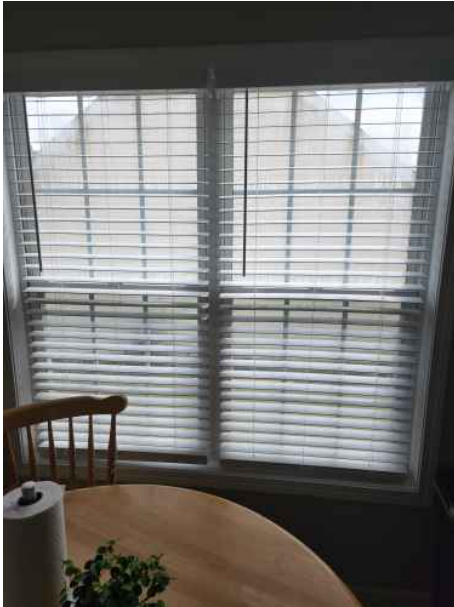
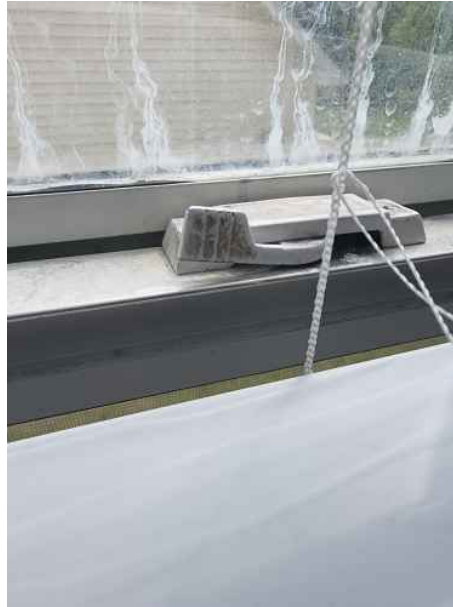
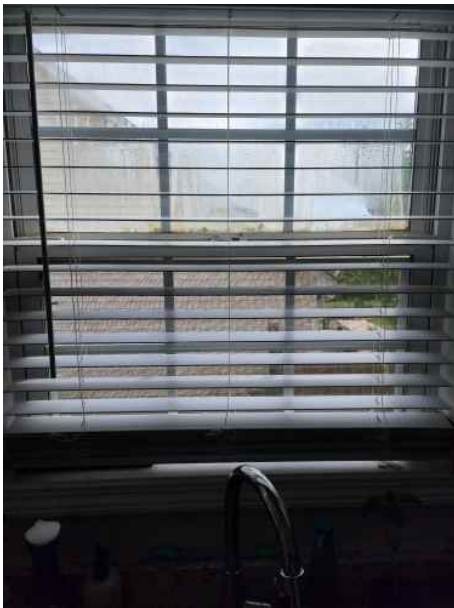
Door lock on right side of window is bent. Recommend repair / replacement by a homeowner or handyman.

Window above sink has visible mildew most likely from a damaged seal.

note All windows in and around home have damaged seals and should be replaced or repaired at the home owners discretion

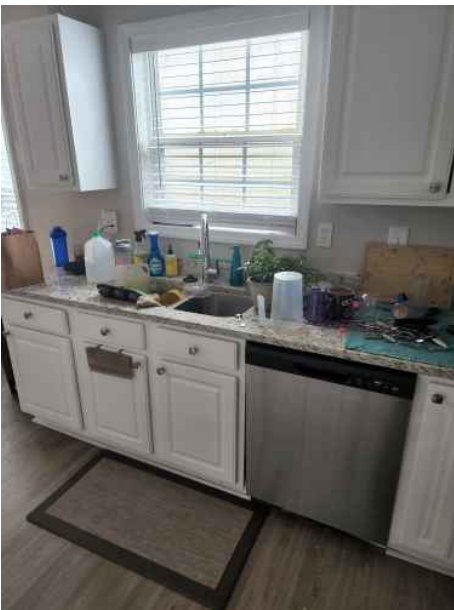
COUNTERTOPS Not Inspected

Unable to inspect due to access limitations.

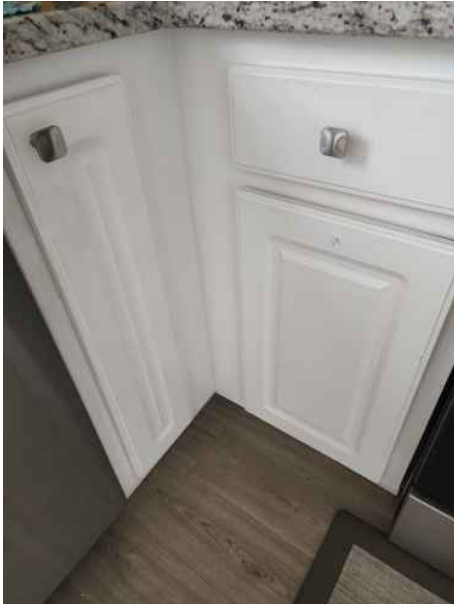
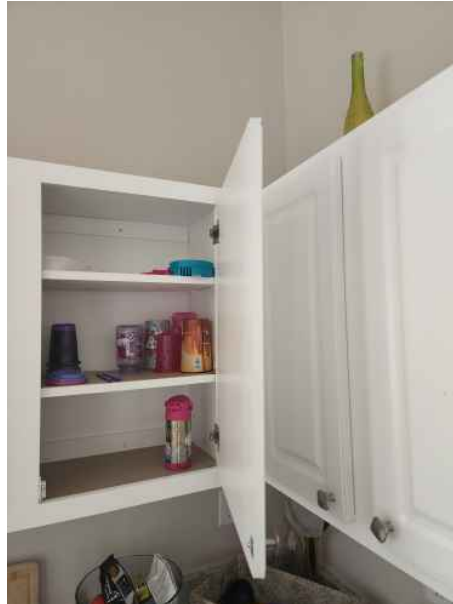
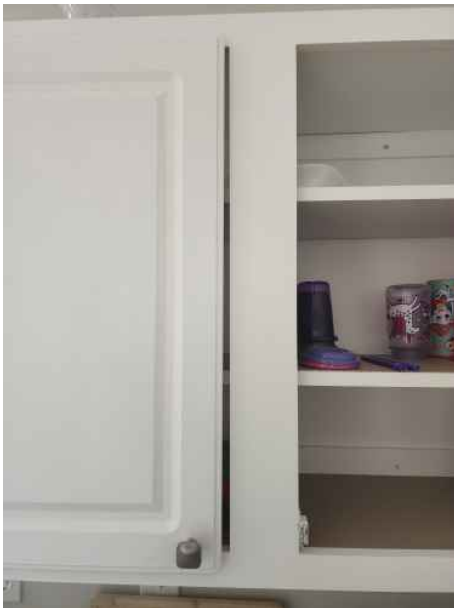
CABINETS Inspected

1 Cabinet nob is missing located to the left of the oven.

Cabinet door above/right is hung improperly and will not stay shut. Also on the same cabinet on the left there is a gap when the door is closed seen in photo.

Recommend repair / replacement by a homeowner or handyman.

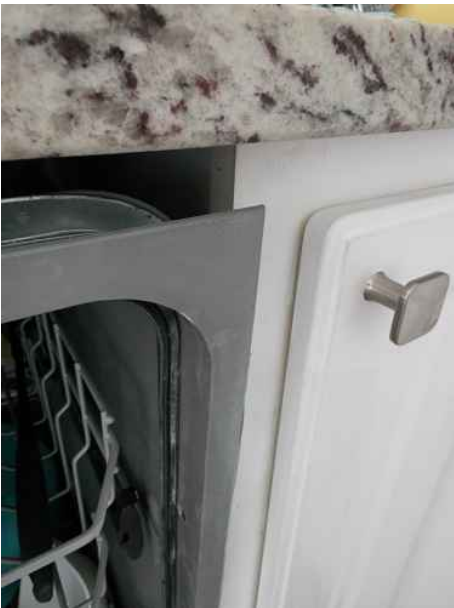
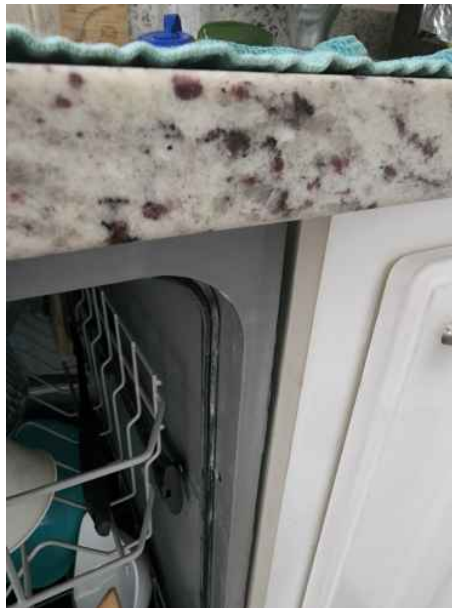
DISHWASHER Fair

Dishwasher functions properly but is missing the anchoring bolts and may tip over when loaded or pulled on by a child.

Recommend repair / replacement by a homeowner or handyman.

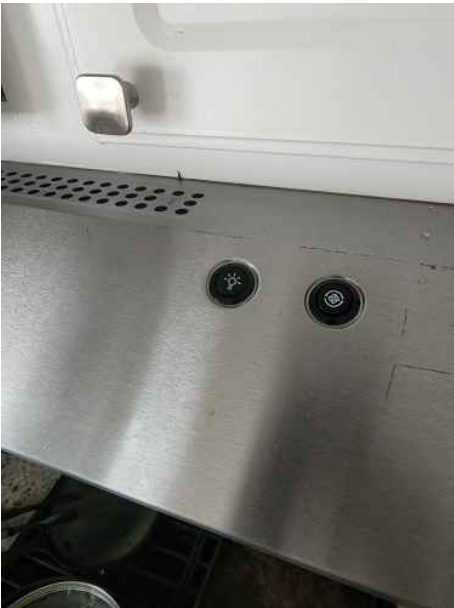
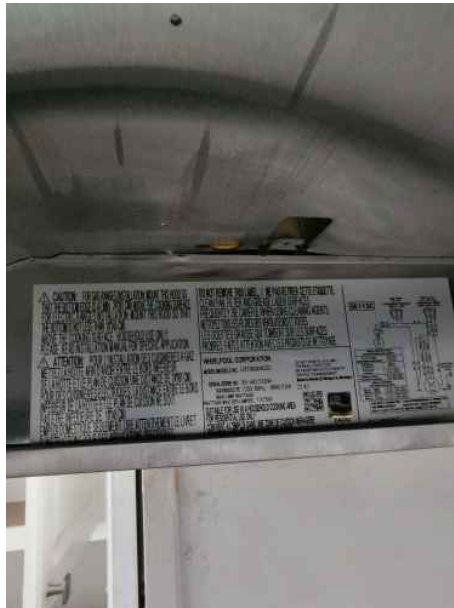
EXHAUST HOOD Poor

Oven exhaust hood did not turn on under normal operating conditions during the inspection.

Recommend repair / replacement by a homeowner or handyman.

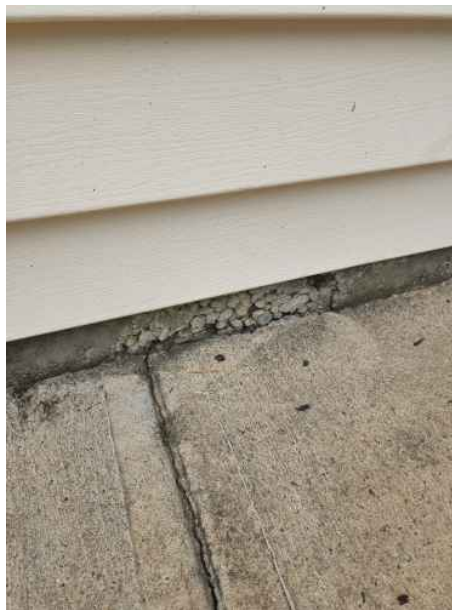
Foundation deterioration can be observed around all sides of the home.

Recommend further evaluation by a qualified foundation specialist or structural engineer.

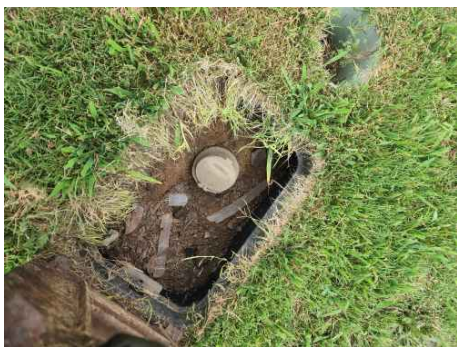
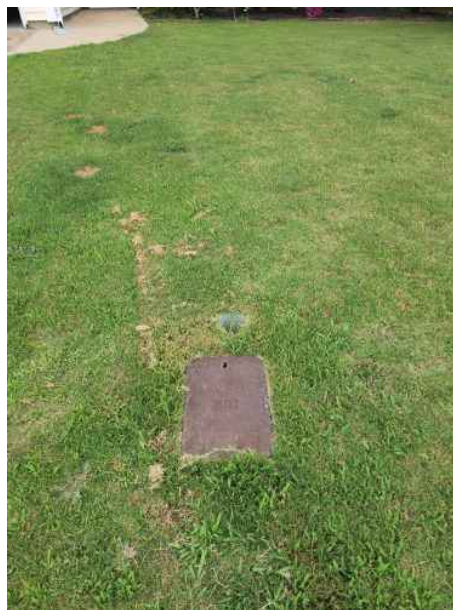
MAIN SHUTOFF VALVE Satisfactory

Located in the front of the home by the water meter.

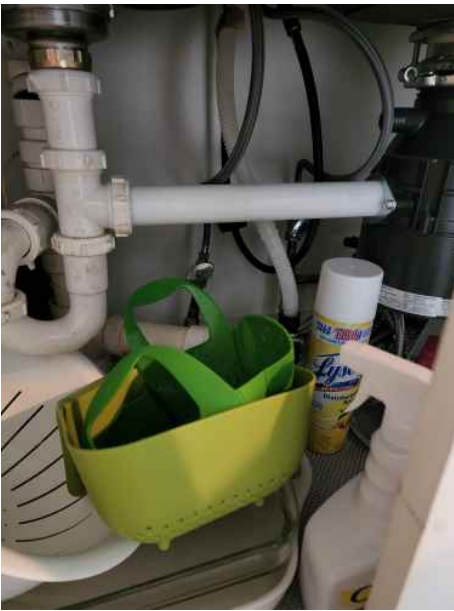
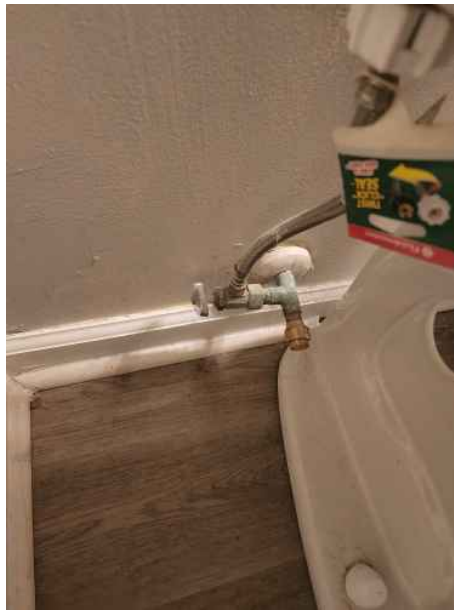
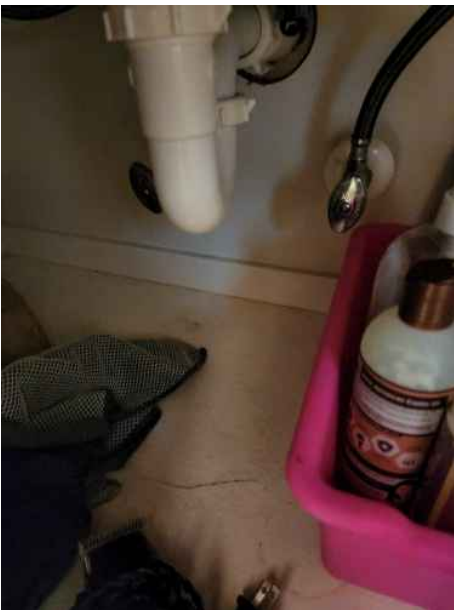
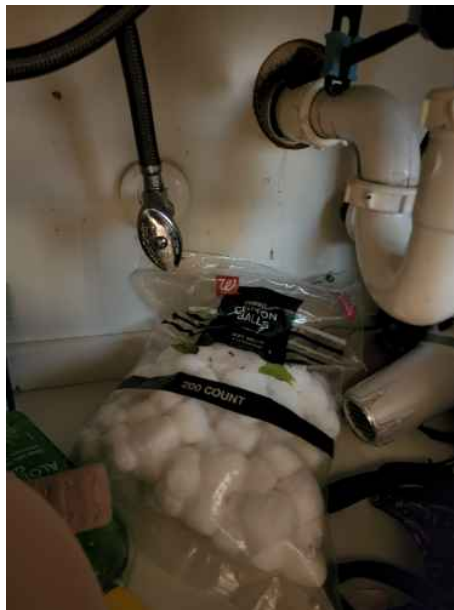
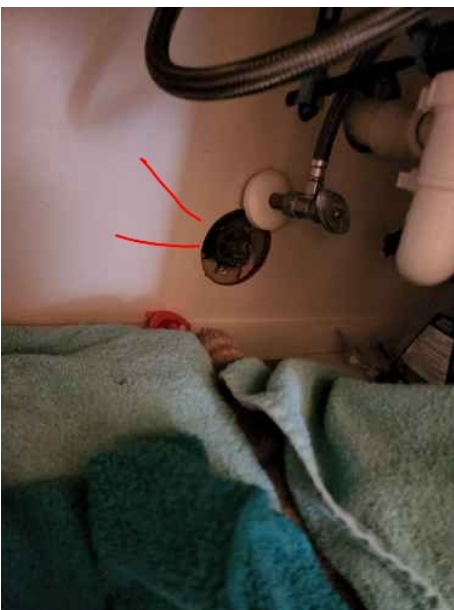
SINK / TOILET SHUTOFF VALVES Fair

Shut off valve on guest bathroom has a whole under it that needs to be capped and or sealed.

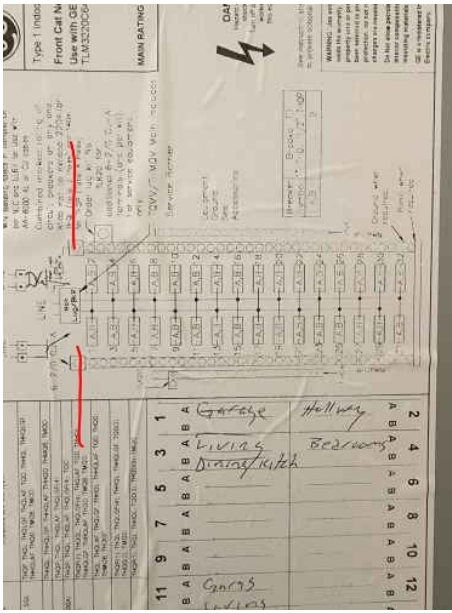
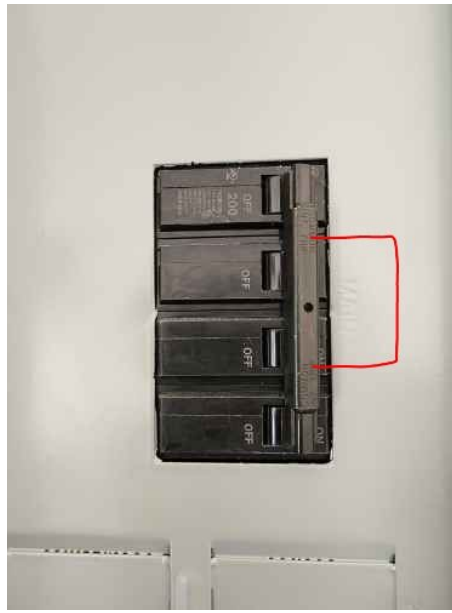
MAIN DISCONNECT Satisfactory

Main shutoff is located within the breaker box within left side of the garage, see photos below

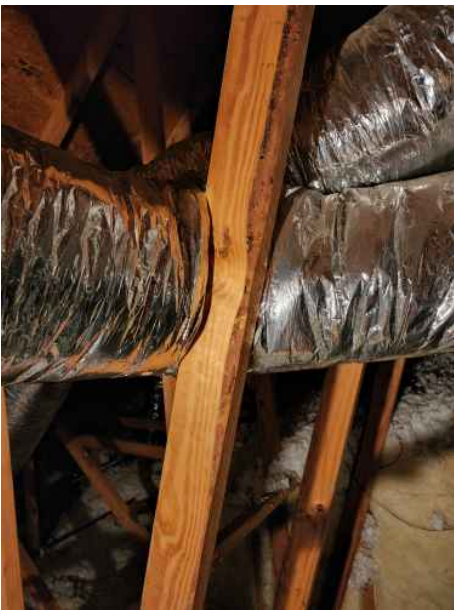
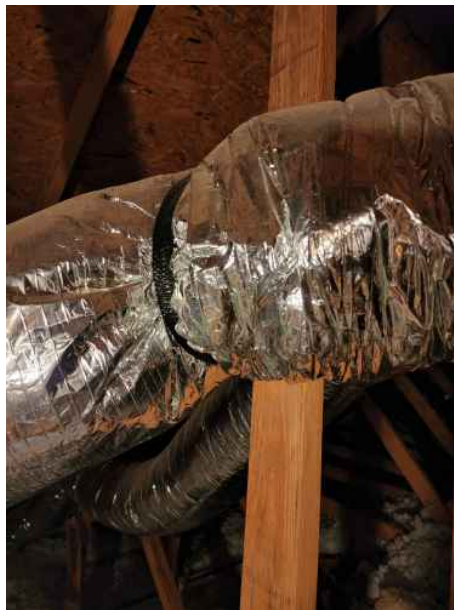
2 of the heating ducts have small constructions due to routing. System is operating correctly
