Victory Property Inspections

August 5th 2022, 12:25 pm

General Information

BUILDING ADDRESS: 1000 Mid Town
CITY: Atlanta
STATE: Ga
ZIP CODE: 30067
INSPECTION DESCRIPTION: Mid rise condo 800sq ft, 1bedroom, 1 bath. Built 2001, with 1 garage parking spot. Buyer present
SQUARE FOOTAGE: 800

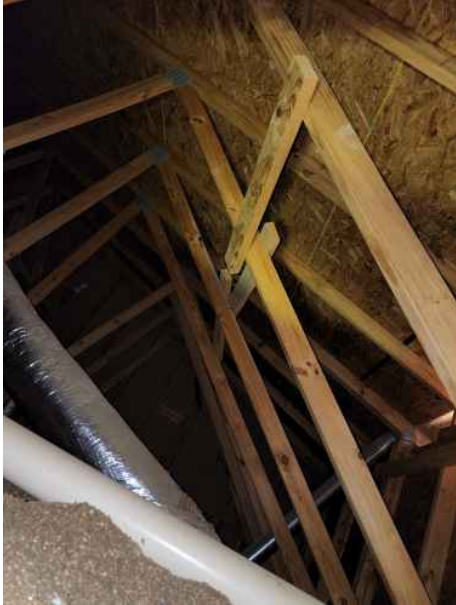
Viewd with limited visibility. At the time of inspection no defects were observed with what could be seen

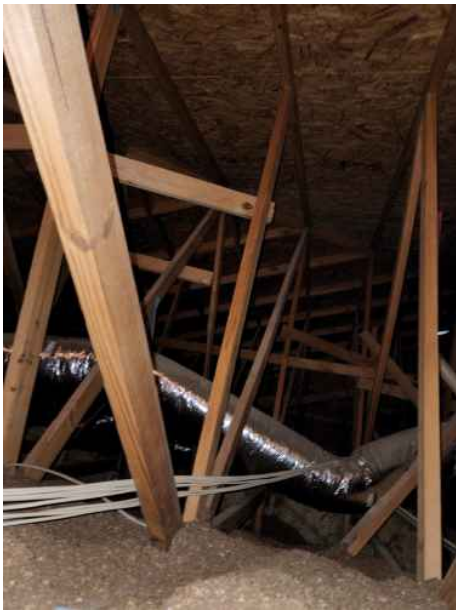
Viewed with limited visibility. At the time of inspection no defects were observed with what could be seen

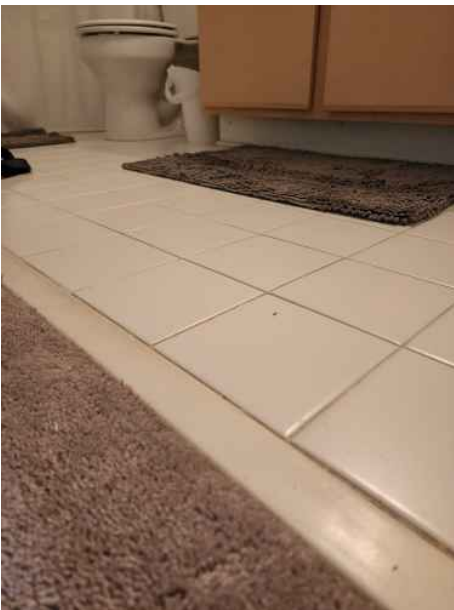
Tiles missing grout to the left of the toilet seen in 2nd and 3rd photos.

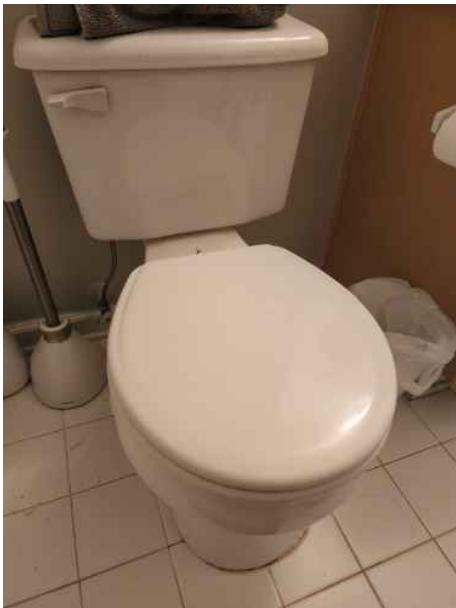
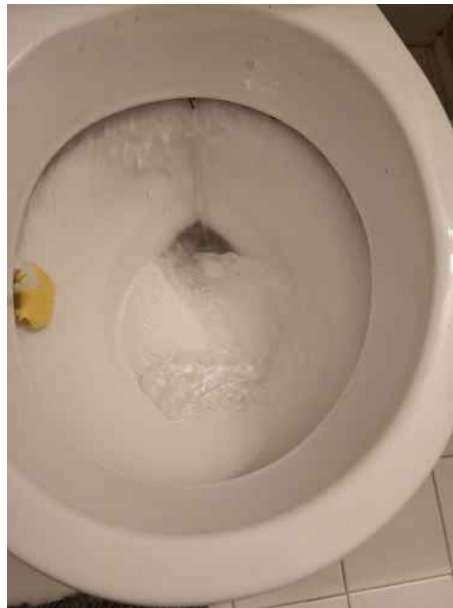
Floor seal around toilet should be replaced to prevent any water intrusion into the floor. Seen in 3rd photo

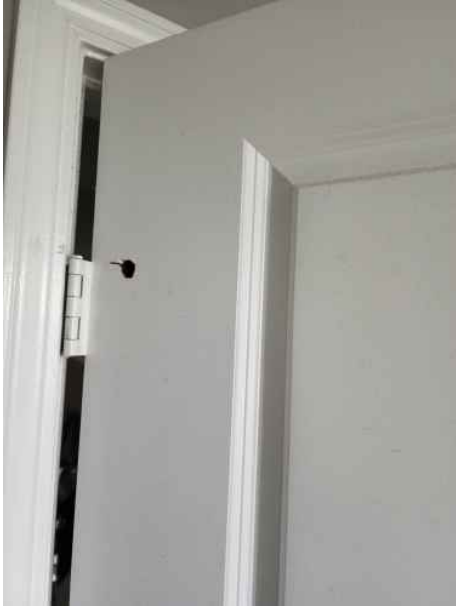
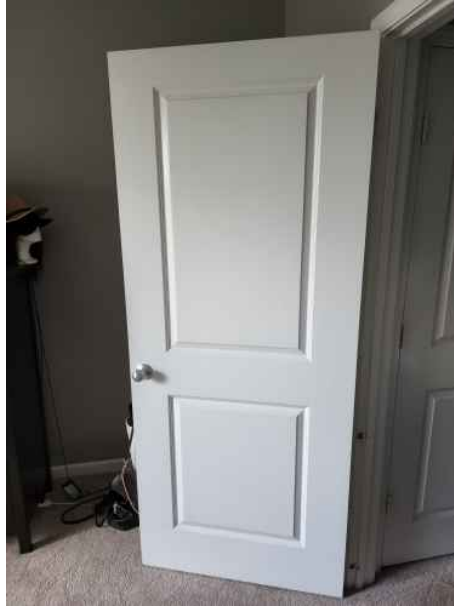
Whole from previous door stop is located at the top of the backside of the door.

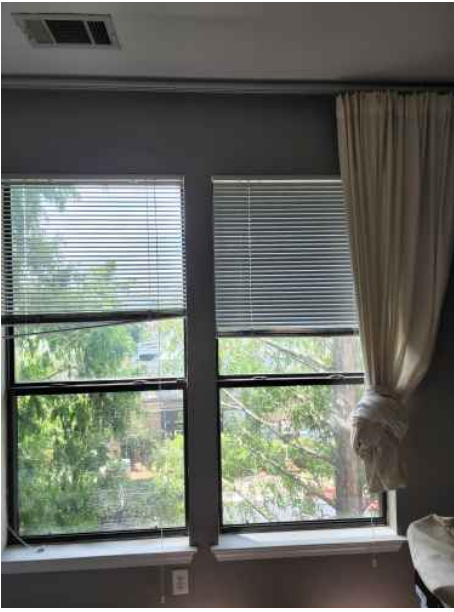
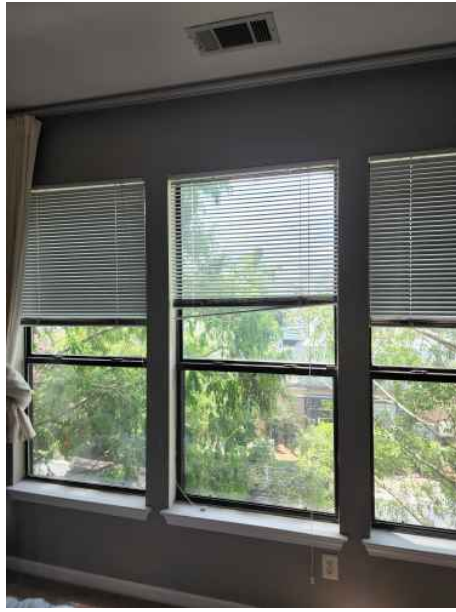
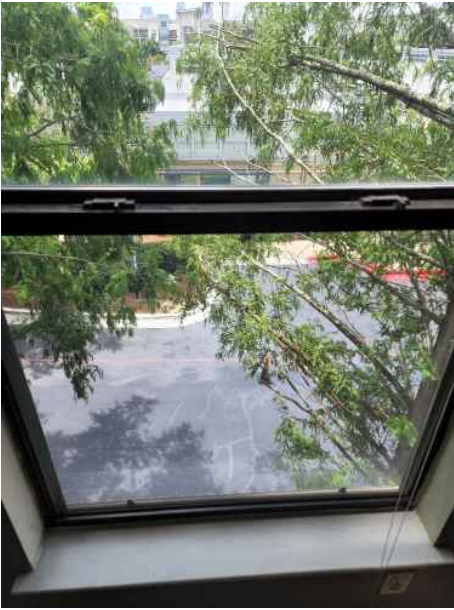
Window operation is a little stiff, all windows open and close and operate correctly

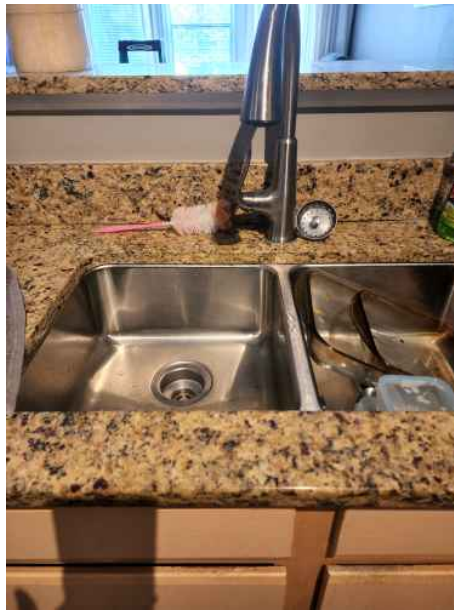
Sealant behind kitchen sink needs to be replaced, seen in first photo.

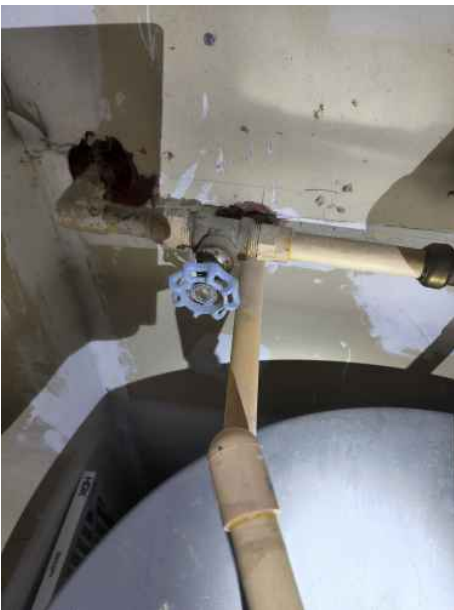
Located in mechanical room, turn dial on the left side

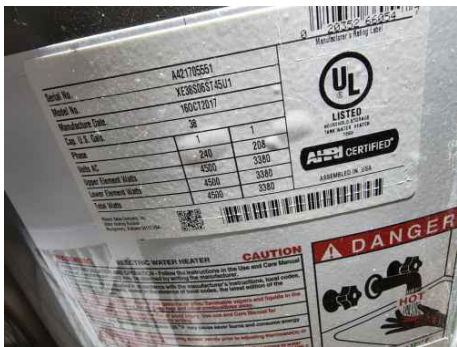
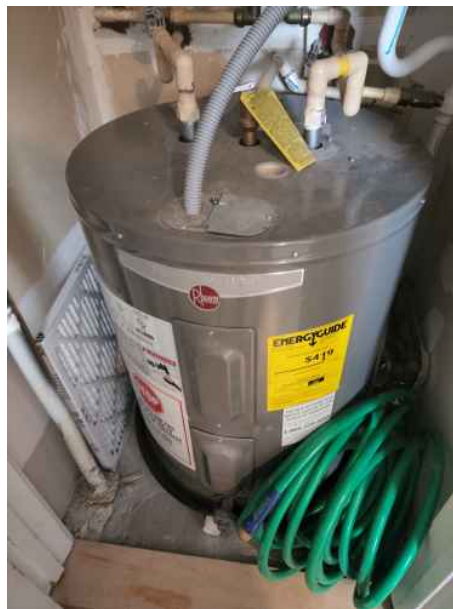
38 gallons

Made Oct. 2017 (5 years old) typical lifespan is 10 years

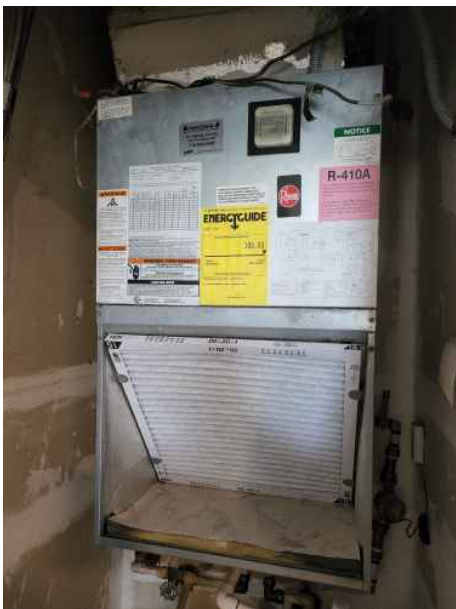
Built in 2011. Check notes later

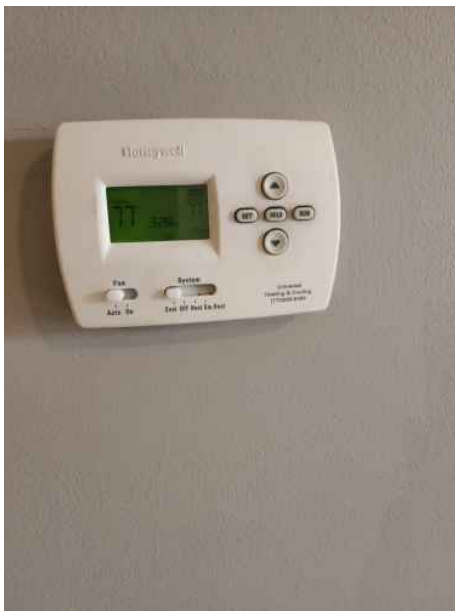
THERMOSTAT Satisfactory

Located on left side of the living room wall

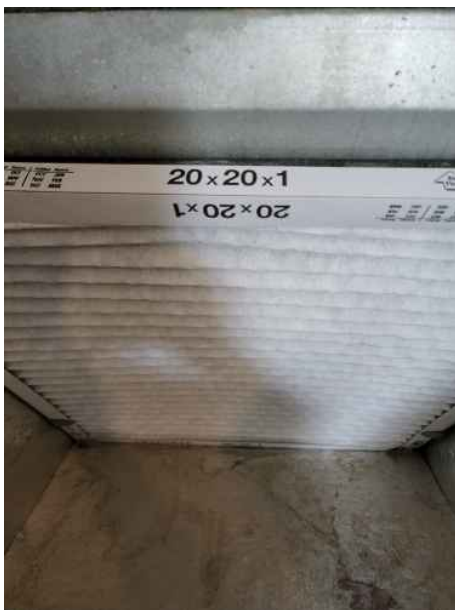
AIR FILTER(S) Satisfactory

20x20x1
